REPORT OF THE MARINE SURVEY

"Carol Cee 3"

2004 Grady White Marlin 30

Peter J. Spang, SAMS® AMS®

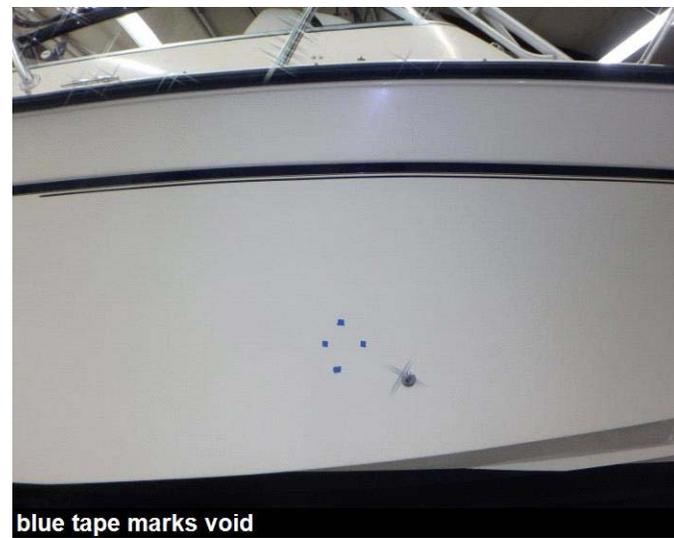
2.11 Moist./Delam.:

Moisture meter readings on topsides near the water line and surrounding thru hull fittings are relatively dry. Cuprous fresh anti-fouling paint gave false high readings by the moisture meter but small areas of older paint show dry readings. Percussion testing with a phenolic hammer on a 6" grid pattern reveals: What appears to be solid laminate. *Higher up on the stbd side a small void*

was discovered by sounding. See photo. Watch area for stress cracking- repair is optional. At this point moisture level is not elevated. There is no easy access to this area inside the hull.

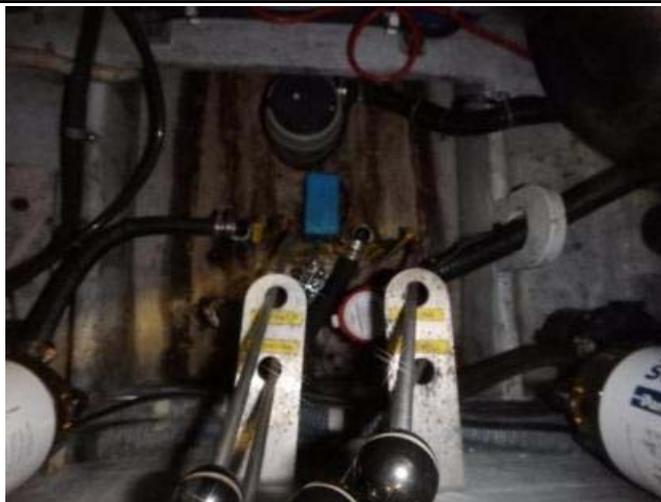
2.28 AFT BILGE :

Bronze seacock ball valve(s) installed. Valves are functional and accessible via extensions.

Thru hull valves used for: Deck wash down inlet, baitwell pump inlet, generator raw water intake, and air conditioner raw water intake, **Sea valve(s) are piped with:** Marine rubber covered reinforced hose. Hose connections are double clamped. **Sea**

strainer(s) installed in the area for: Generator raw water cooling and air conditioner heat exchanger pump. Sea strainer(s) appear clear of debris.

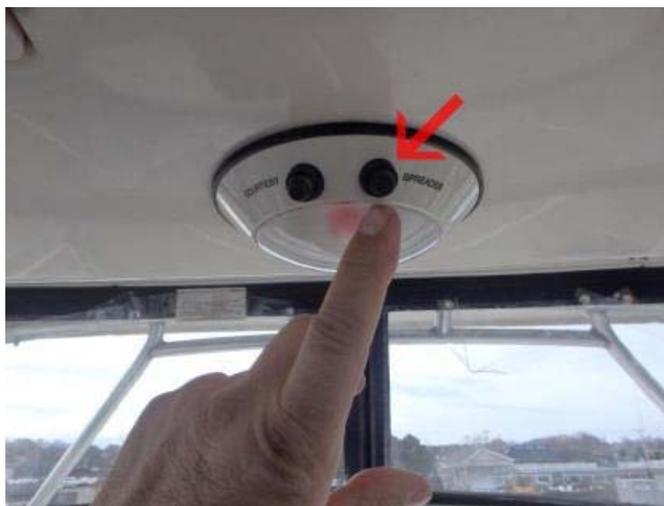
3.26 Cockpit Equipment:

Cockpit has courtesy lights that power up. Cockpit flood lights installed, **do not power up, repair or replace switch as necessary.** Sink/Wet bar, handheld shower installed, with cold water only. Not tested. (No water in system). Vinyl coaming pads are in good condition. Coaming compartments for rod storage.

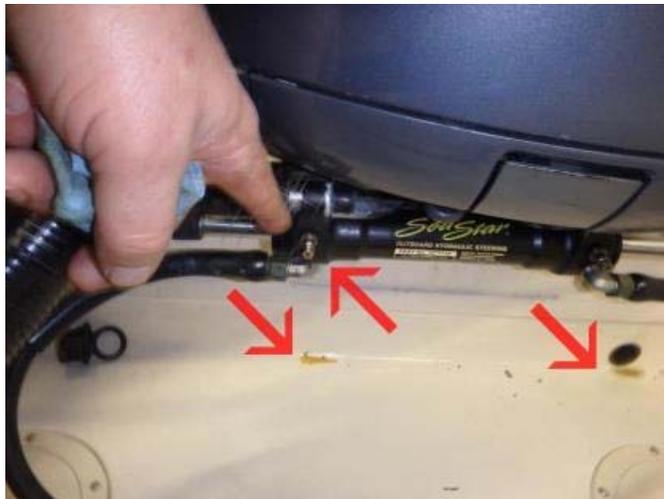
6.5 Lines and fittings:

Flexible hydraulic lines from steering head to ram(s). **Leaks sighted at: Stbd engine ram. RECOMMEND: Repair hydraulic fluid leaks in steering system.**

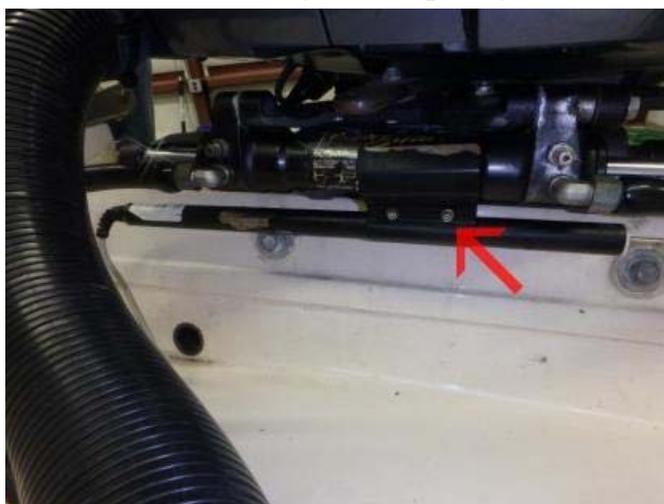
6.7 Mounting(s):

Cylinder & ram actuator well secured-no leaks sighted. **Rudder position indicator on stbd engine ram for the auto pilot is loose- tighten clamp securely.**

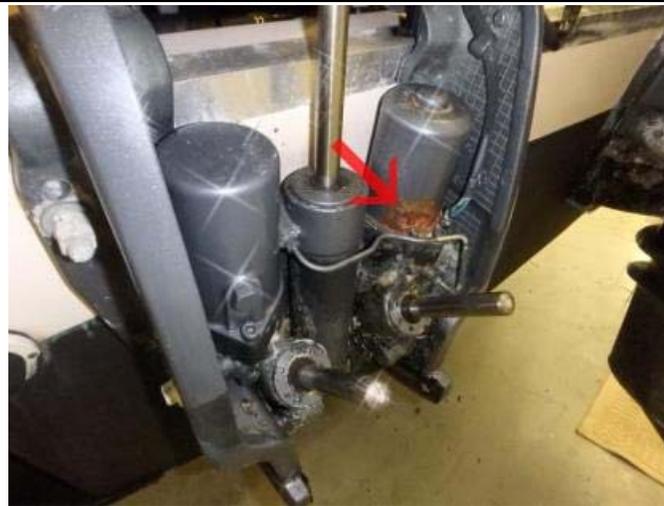
7.27 Tilt /trim /trailer:

Powers up & appears functional. No leaks seen. **Trim indicators at the helm are not operational. Sending units are moving stiffly- repair or replace.** Braided bonding wires are attached, appropriate and apparently serviceable. **Stbd hydraulic motor is corroded but serviceable. Descal rust and repaint.**

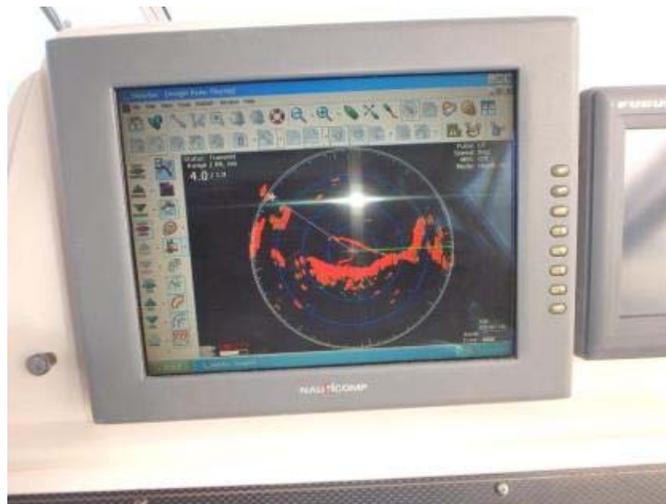
8.8 Multi-function:

Nauticomp system with navigation computer. Instrument powers up. **Could not get GPS fix.** Radar OK. (GPS antenna appears to have been repaired at some point).

Note: It should be determined if the GPS segment of the navigation system can be repaired. If not, consideration should be made for replacement and installation of a new package.

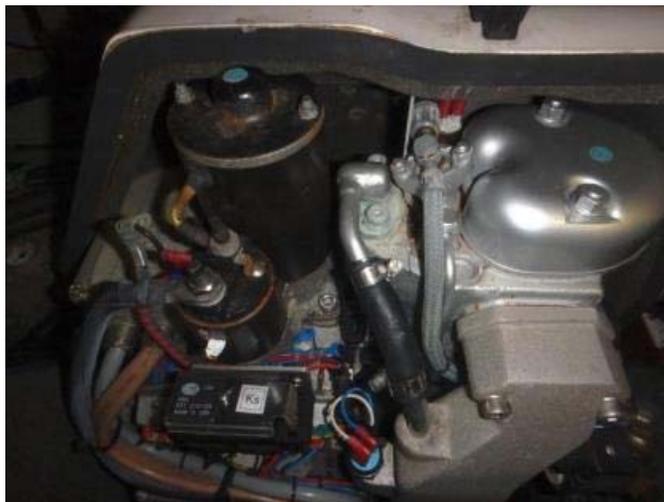
9.7 Generator:

Fischer Panda, powered by a: single cylinder, diesel engine. Generator is cooled by: raw water only, via a sea water strainer and discharged through the wet muffler and exhaust. Wet type marine grade reinforced hose, double clamped at all connection. Wet muffler exhausts to topsides thruhull outlet. System installed to ABYC recommendations.

Started easily and performed adequately. Operator manual not on board and information label on the generator could not be seen. Generator operated at the sea trial and performed satisfactorily although quite noisy. Operator's manual should be available online.

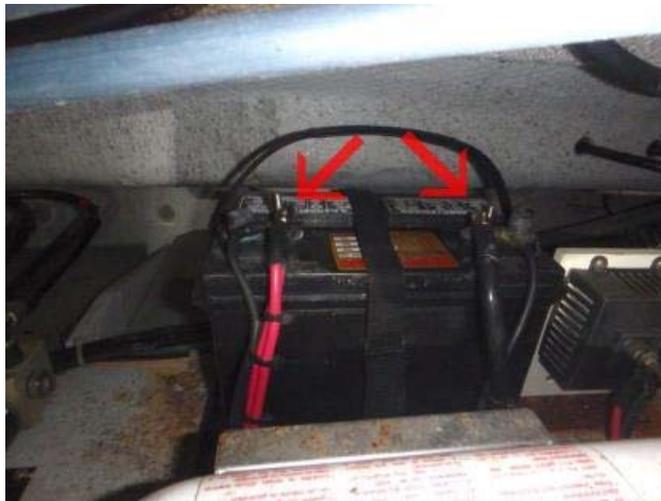
9.10 Storage:

Genset battery terminals are not protected as required. Code of Federal Regulations - CFR33.183.420 mandates that ALL non-grounded battery (+) and DC circuit terminals be protected against accidental shorting by the use of insulation barriers or sleeves or compliant battery boxes with covers.

Recommend compliance with CFR and insulate all non-grounded battery and DC terminals. Wing nuts are not appropriate for heavy cable (6 AWG or larger) connections to the battery per ABYC10.8.3. Replace with SS nuts.

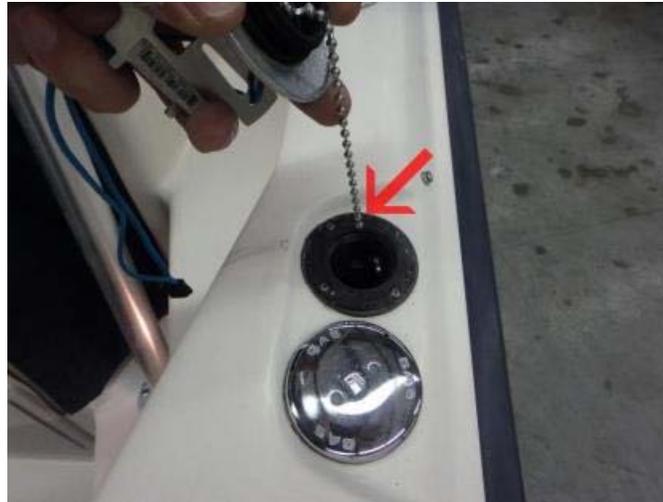
10.15 Fuel fills located:

On the side deck, starboardside. The deck plate is clearly labeled, appears weather-tight and serviceable. O-ring on cap is in good condition. **No tether or broken tether on the forward fuel fill cap. ABYC H-24.13.5 recommends the fill cap be permanently tethered or somehow attached to the deck plate. Repair or replace.**

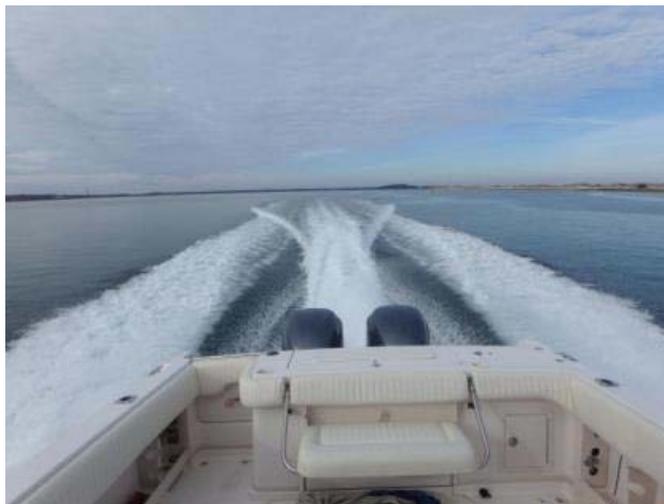
Manufacturer's recommended max RPM is 5000-6000 Engines reached 5900-6000 RPM at full throttle.
