REPORT OF THE MARINE SURVEY

**As requested, a Pre-purchase Survey was conducted, but not completed, of
"Straight Out"**

2003 Ocean Master 31 Center Console

1.3 Report file no: 022817oceanmaster31colabro.

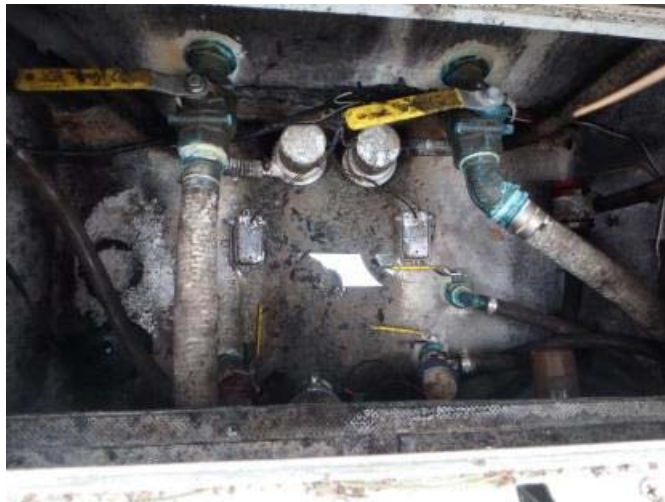
2.19 Bilge(s):

Clean with some standing clear water. **Some black mold sighted in bilge and other closed in areas. RECOMMEND spraying with mild bleach or vinegar solution, then hosed out. Ways to ventilate these areas would help.**

1. Some black mold sighted in bilge and other closed in areas. RECOMMEND spraying with mild bleach or vinegar solution, then hosed out. Ways to ventilate these areas would help.

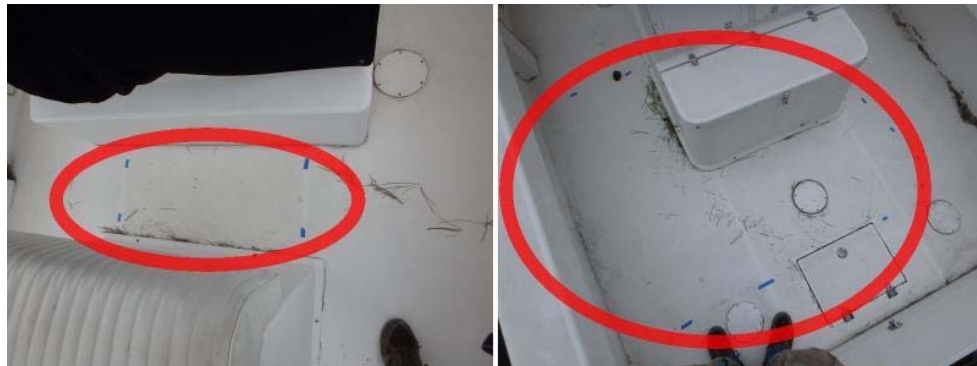
3.5 Moist /Delam:

Abnormally high, (wet), moisture meter readings and/or delaminated or soft deck(s) on the cockpit sole are as follows: most of the aft cockpit and beneath the helm. Extensive repair necessary.

2. Abnormally high, (wet), moisture meter readings and/or delaminated or soft deck(s) on the cockpit sole are as follows: most of the aft cockpit and beneath the helm. Extensive repair necessary.
