REPORT OF THE MARINE SURVEY

As requested, a Pre-purchase Survey was conducted of

"Fortuna"

1986 Shannon Brenden 32

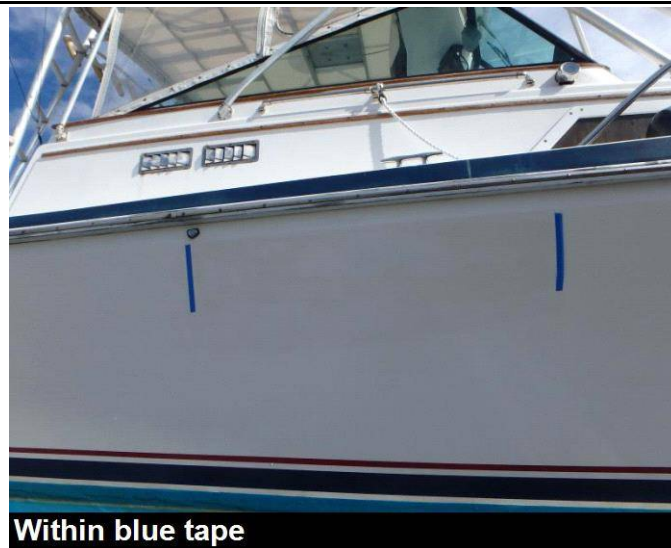
2.5 Hull cosmetics:

Hull cosmetics are in fairly good condition-minor nicks and scratches. *Two identical areas amidships both sides show a rectangular area with stress cracking, slight discoloration, and high moisture levels. Cause unknown. When tapped, sounds solid.*

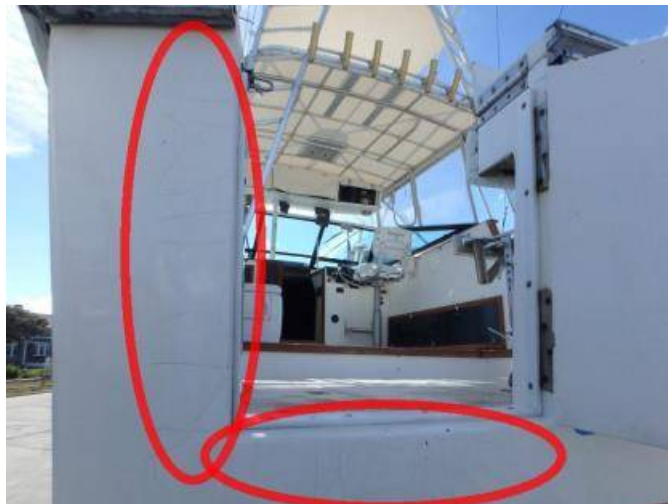
2.7 Transom:

Flat transom. Tuna door in transom. Door is solid, hinges tight, latch secure, opens and closes easily and tightly. Appears serviceable. Transom is well secured, no cracks or defects sighted. Moisture readings were relatively dry. No soft or delaminated areas revealed when tapped. *Stress cracks sighted surrounding the tuna door.*

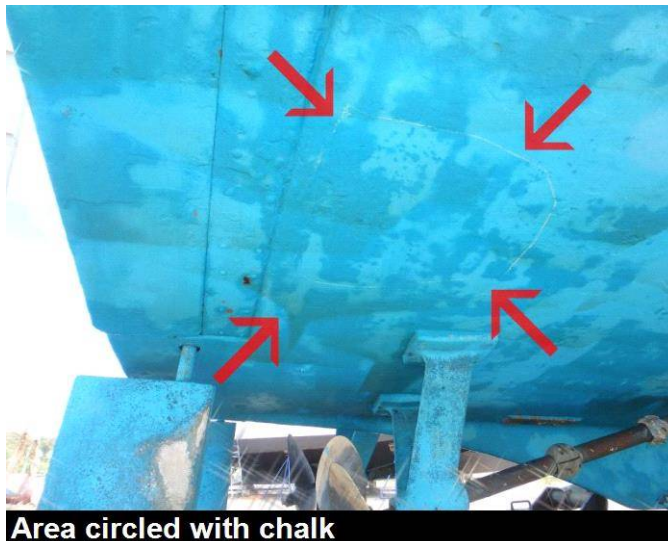
2.10 Moist./Delam.:

Moisture meter readings on topsides near the water line and surrounding thru hull fittings are relatively dry. Cuprous anti-fouling paint gave false high readings by the moisture meter and but small areas of bare hull show dry readings. Percussion testing with a phenolic hammer on a 6" grid pattern reveals: *What appears to be solid laminate except in one area forward the trim tab recess. Corresponding area inside the bilge shows high moisture. Watch this area for cracking or blisters.*

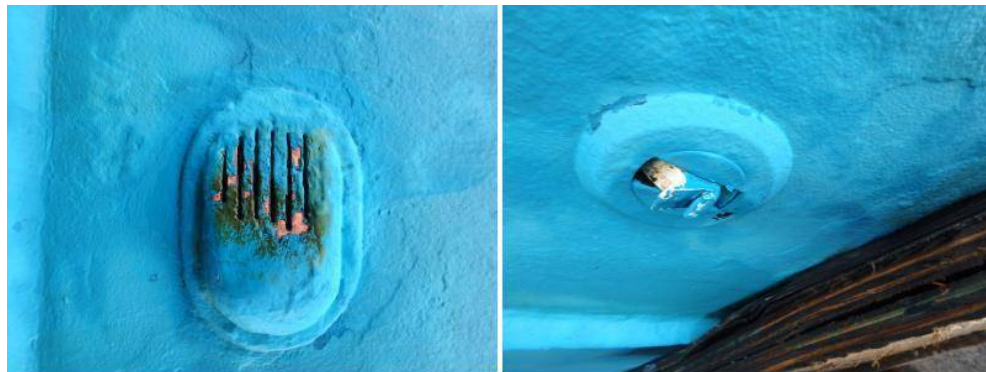
2.12 Thru Hulls

All thru-hull fittings were adequately sealed and bonded to hull as sighted from exterior. **Raw water baitwell intake screen damaged. Paddlewheel transducer damaged.**

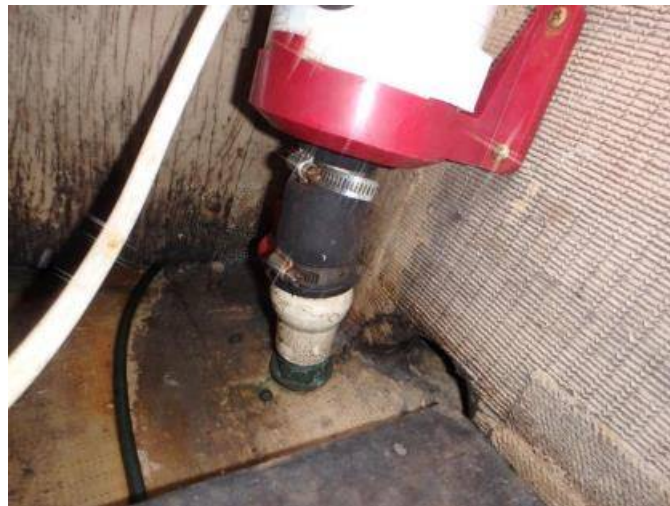
2.27 AFT BILGE :

No valve(s) installed on washdown thru-hull -- installation required per ABYC H-27.5.1 on all penetrations at or below waterline.

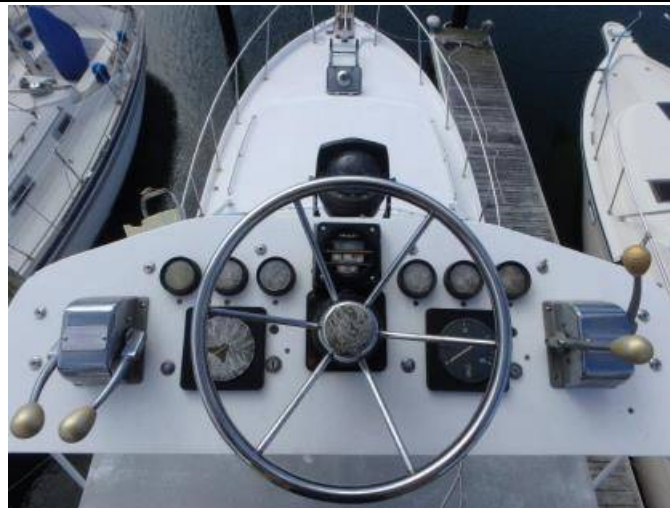
3.21 Helm & Seat(s):

Upper helm is not functional. All gauges need to be replaced. Throttle and shift not functional. VHF radio not functional. Steering works and compass OK.

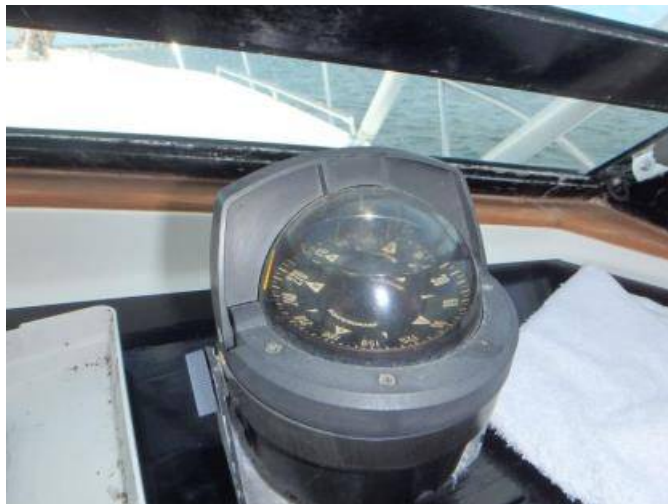
8.2 Compass(es):

Ritchie. Powerdamp. and with a 3" card. Lighted and shaded. Located on the helm dash. The compass appears functional. **The compass' fluid has leaked out. RECOMMENDATION: Repair or replace compass to restore full functionality.**

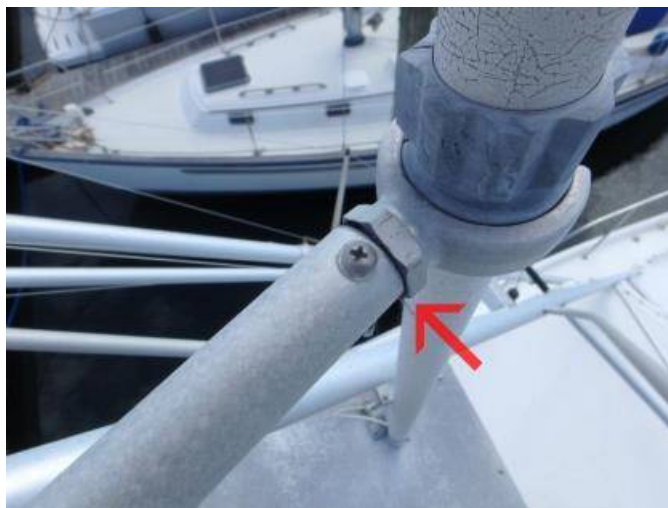
8.11 Antenna(s):

Noted the port side VHF antenna stabilizer is very loose- tighten or repair as necessary.

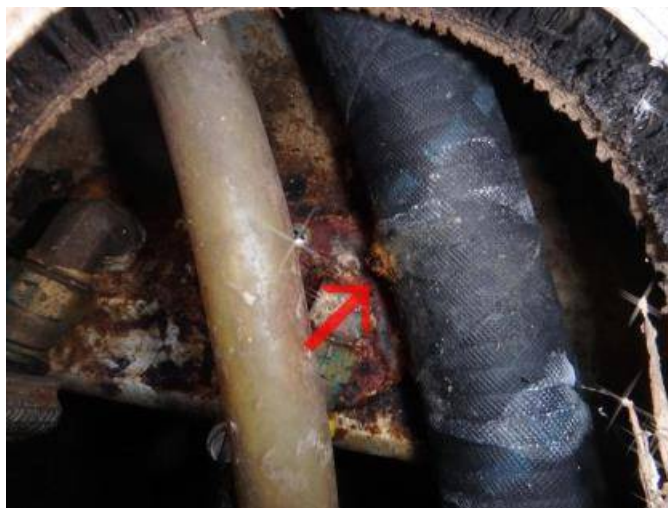
10.17 Fill pipe:

Could not see entire length of fill hose thru access port. Fill hose is properly double clamped at both ends of fill hose. **Stbd flex fuel fill hose is damaged from abrasion and appears to be original. RECOMMENDATION: Replace damaged fuel fill hose with USCG approved Type A fuel fill hose and double clamp.**

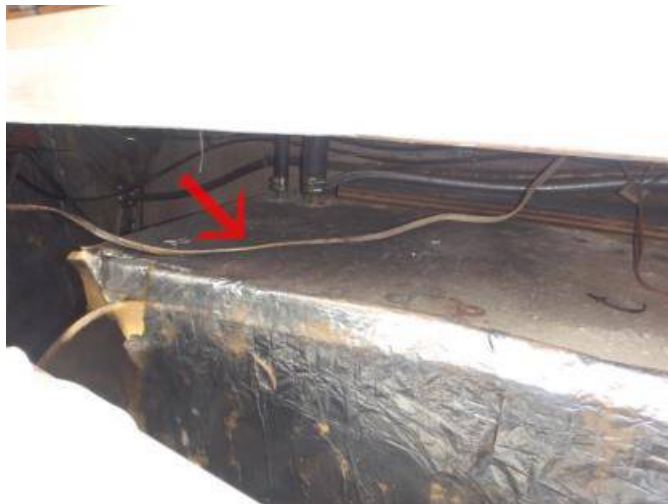
10.18 NOTE:

AC wire laying on top of tank stbd side. This is a fire hazard- reroute wire.

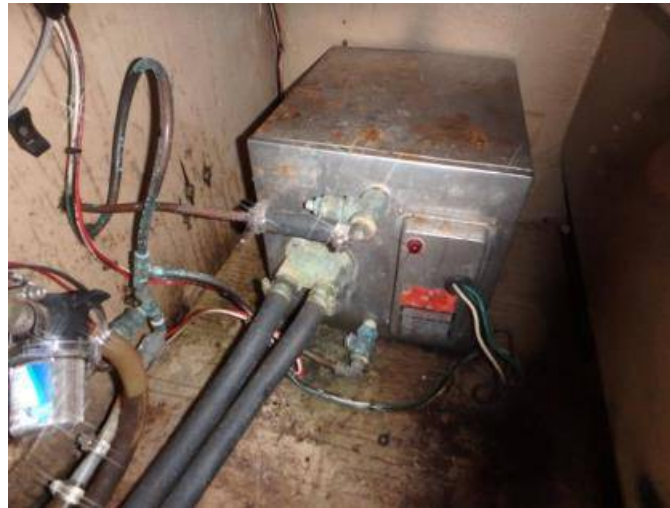
Hot water heater is old and replacement should be considered. Water heater AC wiring is not compliant.

Good.
 Old.
 None sighted on the hot water heater. **RECOMMEND: A pressure relief valve should be installed on the water heater** for safety Plumb to either an external thru-hull fitting or a harmless area of the bilge. ABYC H-23.7.2.
 Yes.
 Did not observe label on water heater as being ignition protected. The water heater is not in an explosive environment.
