## **REPORT OF THE MARINE SURVEY**

**As requested, a Pre-purchase Survey was conducted of:**

**2012 Cruisers 310 Express**

**Peter J. Spang, SAMS® AMS®**

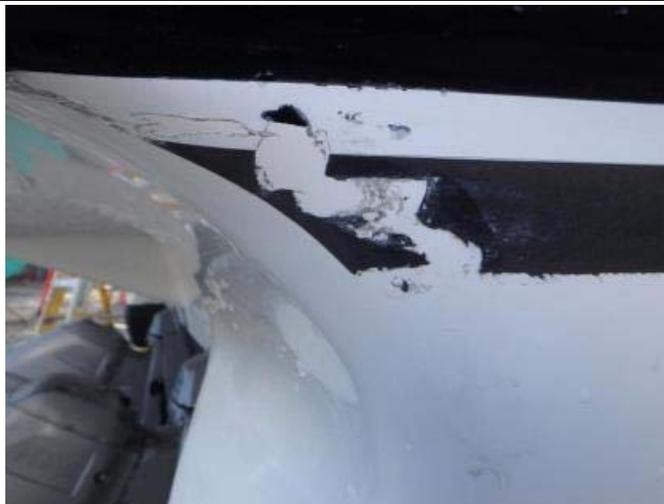
## 2.5 Hull cosmetics:

Excellent condition-well protected and no severe external scratches chips or abrasions were sighted except for stbd aft corner-vinyl bootstripe damaged.

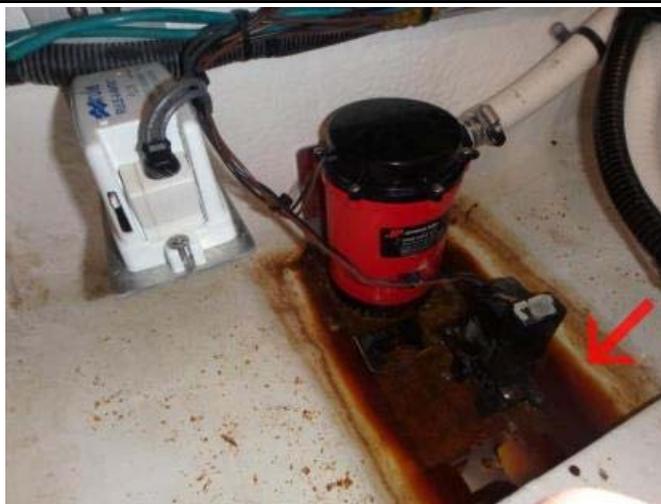
**2.31 Bilge(s):**

Aft bilge is clean with some standing clear water. Forward bilge has rusty colored water. *Clean properly with regards to environmental pollution -- Keep bilge areas as clean as possible to more quickly identify leaks as soon as they occur.*

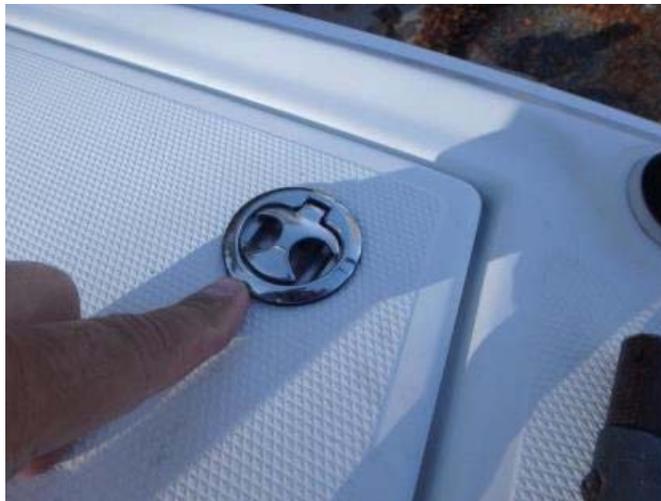
### 3.1 Ground tackle

Ground tackle includes; A single capstan electric windlass. Anchor(s) include: One and plow style. *There is no secondary or backup anchor and rode as recommended in the ways of a prudent mariner. Check to see if the bitter end of the anchor rode is secured to the boat. Anchor locker hatch release is broken- cannot open hatch to*

*survey rode or windlass. Repair latch.*

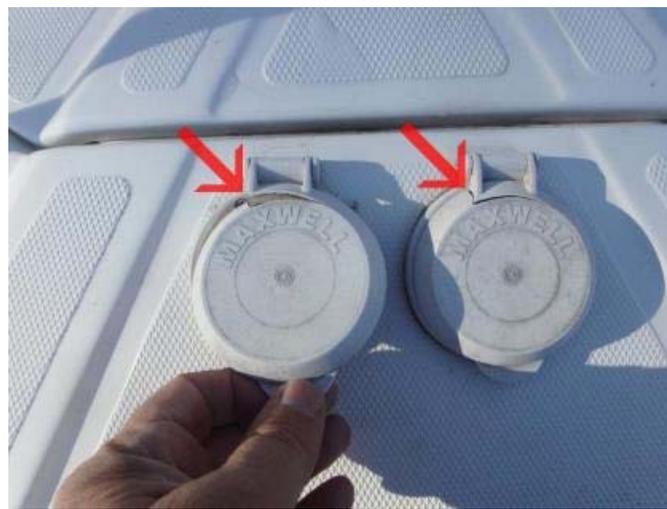
**3.18 Windlass:**

Maxwell, with chain /rope gypsy. Foot controls on the foredeck are operational for raising or lowering anchor. Helm controlled switch is functional. **Foot control covers are broken-replace.**

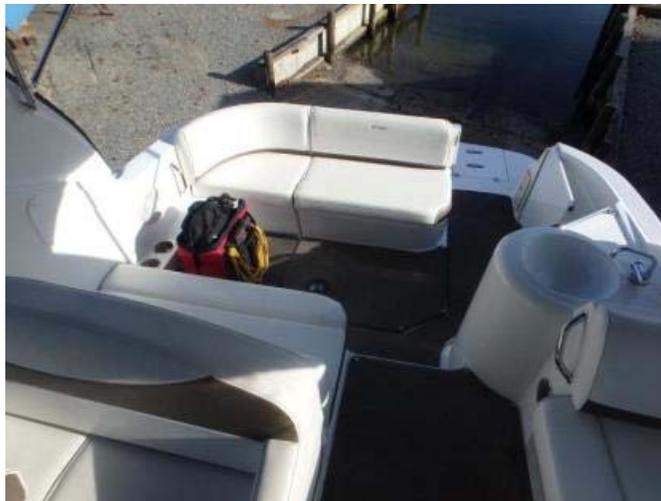
### 3.23 Cockpit Equipment:

Cockpit has courtesy lights that power up. Cockpit flood lights installed, power up and appear serviceable. Sink/Wet bar, Refrigerator/ice maker: Nova Kool AC/DC, Handheld shower installed, with hot and cold water. Not tested. (No water in system). Stowaway cockpit pedestal table. **Nova Kool refrigerator did**

**not power up- repair if necessary.**

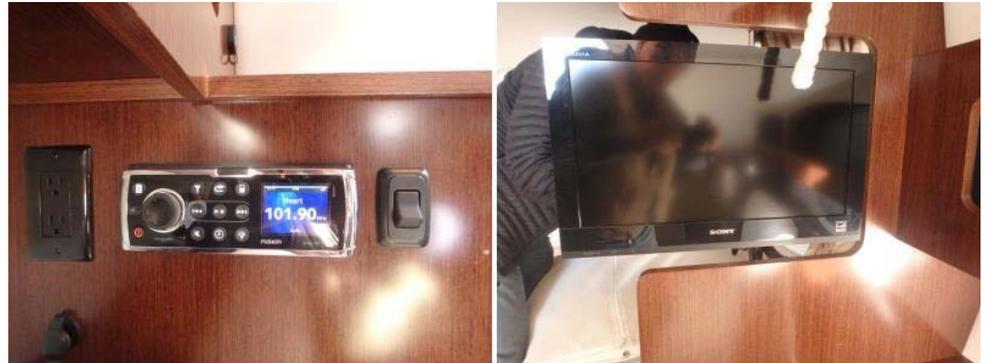
Entertainment includes: An AM/FM/CD/Satellite/MP3 stereo by Fusion, Model MS-IP76. Appears serviceable- CD player not tested. **Remote pad at the helm has moisture behind the bezel.** A LCD Flatscreen TV by Sony, Model Bravia/ KDL-22BX320, Serial # 7806002. Glomex amplified TV antenna. Cable inlet in the transom. DVD player by Fahrenheit- not tested but powers up. **Unable to get sound from bridge deck speakers. Repair if necessary.**

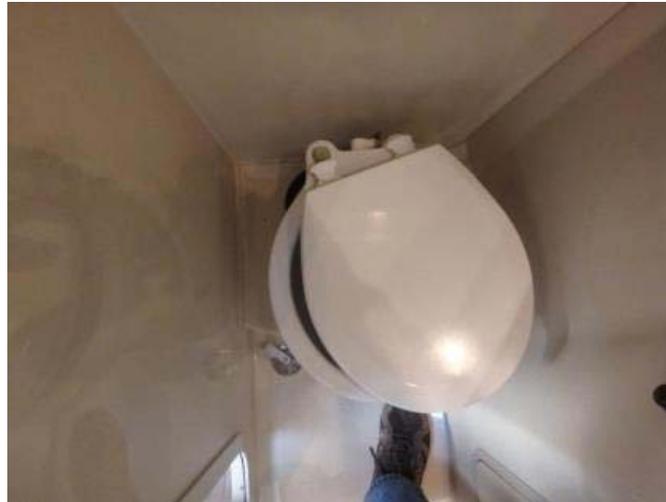
**4.20 Toilet(s):**

Electric flush pump. Flush appears to be jammed. **Toilet does not appear to be serviceable. Renew or repair as soon as possible** so as not to be in violation with CFR33 Part 159. System is winterized. **Replace broken toilet seat.**

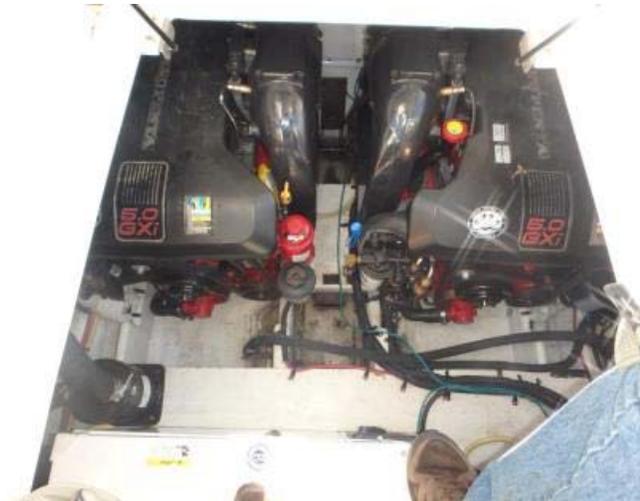
6.10 Make /Model:

- 6.11 Hoses and clamps: Serviceable condition. No soft spots or cracks sighted. Clamps appropriate and in good condition.
- 6.12 Belts and pulleys: Serpentine belt(s) appear serviceable. No cracks or splits sighted. Pulleys/belts appear to be in line. *Belt on port engine is noisy.*

- 6.14 Oil level: **Oil appears dirty. RECOMMENDATION: Change crankcase oil and filter(s) if applicable.** *An oil sample was drawn from each/the engine for independent lab analysis. Engine(s) operated for at least 20 minutes and/or until coolant reached 140 degrees. Sample was carefully and cleanly aspirated from the sump via the dipstick opening. Care was taken to avoid contamination. Results to be emailed separately. Surveyor supports the recommendations of the spectrographic analysis report from the HO Penn laboratory- if any- and does not comment separately.*

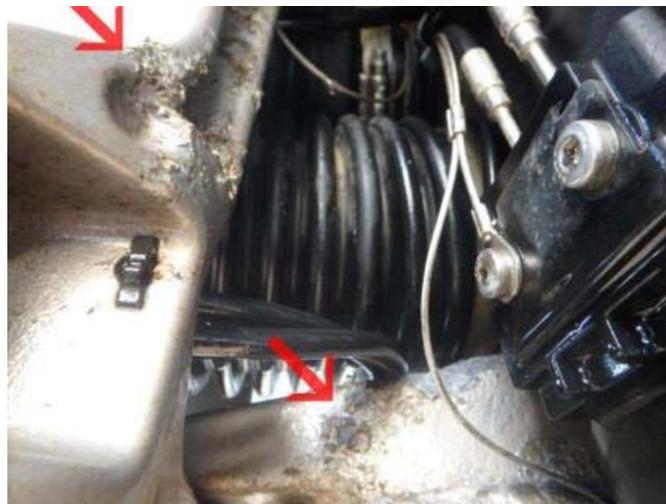
6.28 Appearance:

Apparently in good condition by appearance. *Some corrosion noted on transom bracket.*

**RECOMMEND: Monitor anodes for excessive wasting. Galvanic study of vessel might be indicated.**
