REPORT OF THE MARINE SURVEY

As requested, a Condition & Value Survey was performed of

"CHARLEY J"

1998 Northern Bay 36

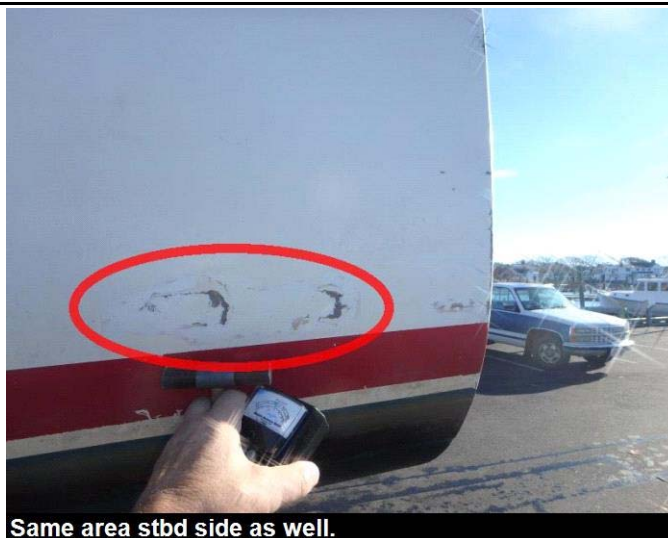
2.5 Hull cosmetics:

Same area stbd side as well.

Hull has been painted. Fair condition with some damage noted. Gelcoat is dull. Scratches, scuffs, in general showing its' age and service. 2 deep digs each side aft have been filled with caulk.

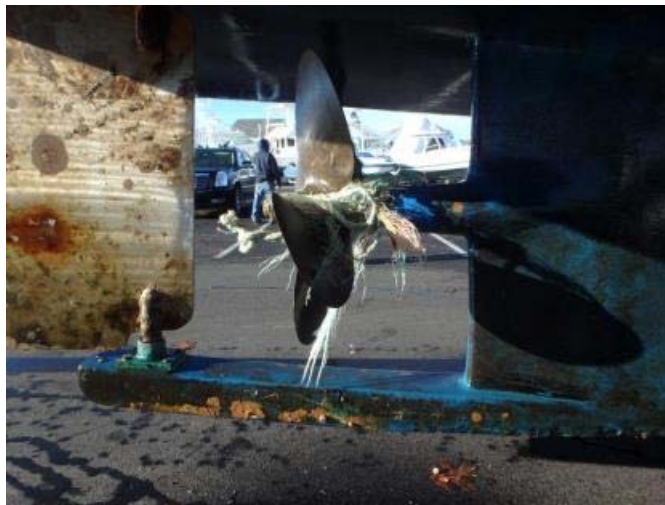
2.11 NOTE:

Prop and shaft were tangled with a polypropylene pot warp. It was removed, but an explanation as to vibration and inability to make wide open throttle.

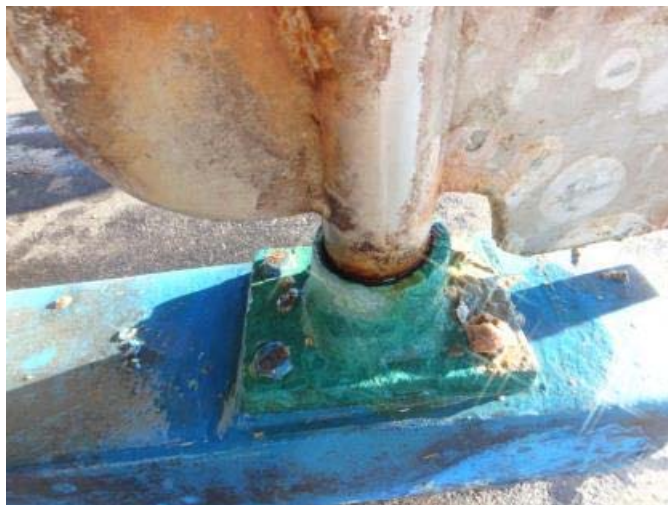
2.26 Condition:

Rudder appears to be in serviceable condition. Slight wear in strut bushing cup, but serviceable as is.

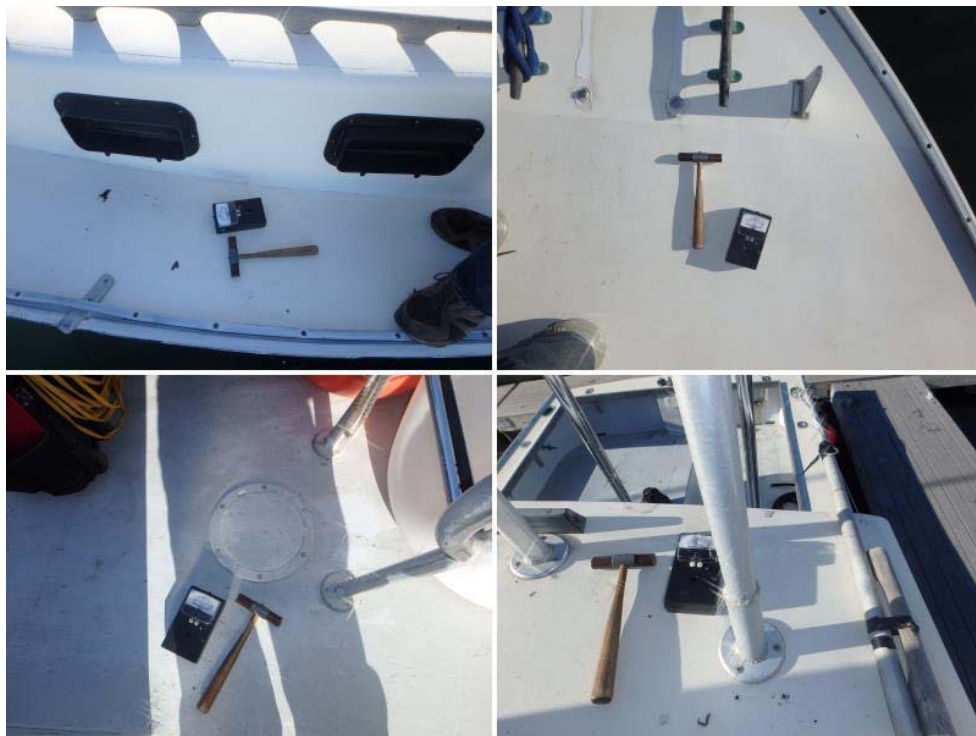
3.8 Moist /Delam:

Higher than normal moisture readings found in deck surface(s) as follows: Scattered small areas of high moisture and dull sounding in the side decks, and cockpit sole. Larger foredeck area forward of the cuddy raised roof and surrounding hatch covers in the cockpit sole. House roof at the ladder from the cockpit. **These areas should be addressed by a fiberglass/deck expert to determine whether repairs, if any, are necessary. RECOMMENDATION: At a minimum, all deck mounted hardware in the areas mentioned should be removed, bedded and remounted properly to prevent further moisture penetration into deck core material.**

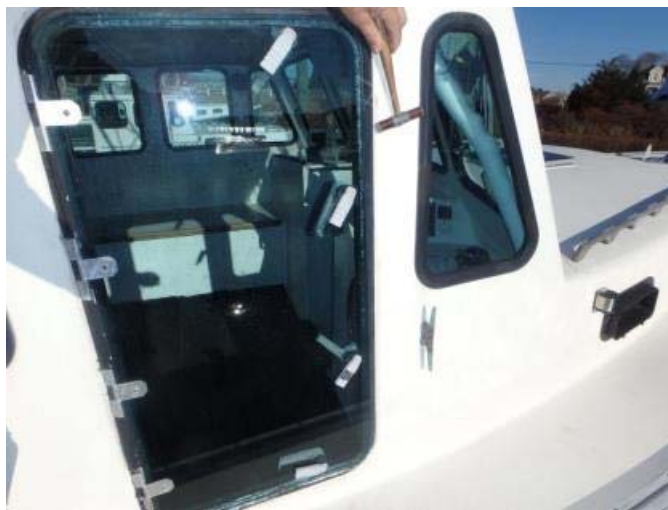
3.10 Window(s):

Fixed windows in cabin structure. Large removable glass door stbd side of house. **(Note in photo- wet and soft area under my hammer)**

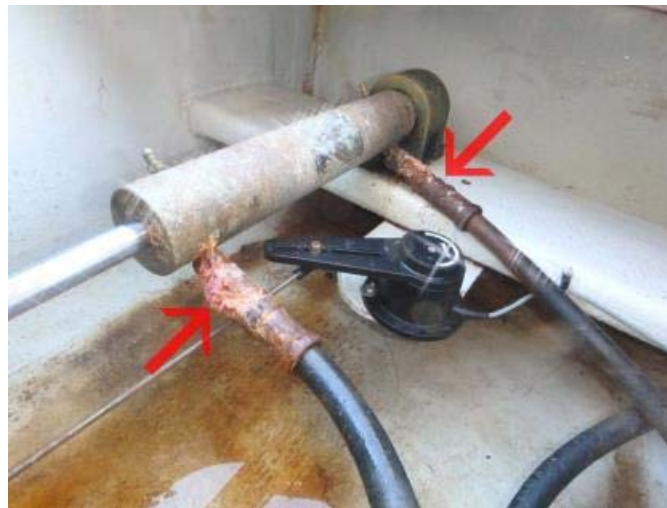
Flexible hydraulic lines from steering head to ram(s). No leaks sighted. **Hydraulic hose crimp fittings at the rudder ram are badly corroded. Recommend replacement.**

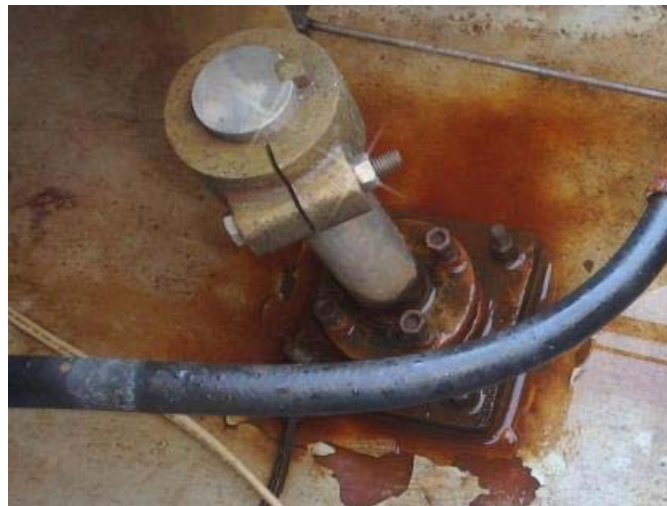
Packing gland shows evidence of water leakage. **RECOMMENDATION: Service packing gland to prevent any water intrusion. Monitor often and adjust as necessary.**

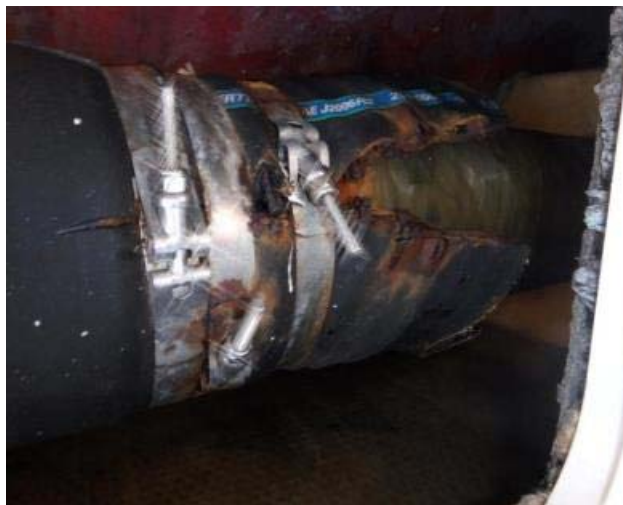
7.31 Piping /Clamps:

Piping: mix of fiberglass and flex hose. Securely double clamped as required. **The flex exhaust hose is showing signs of age cracking and has been split to accommodate a larger diameter pipe. Although the hose appears to remain serviceable it cannot be determined when the hose will fracture through. RECOMMEND: Properly replace all**

cracked or aged engine exhaust hose.

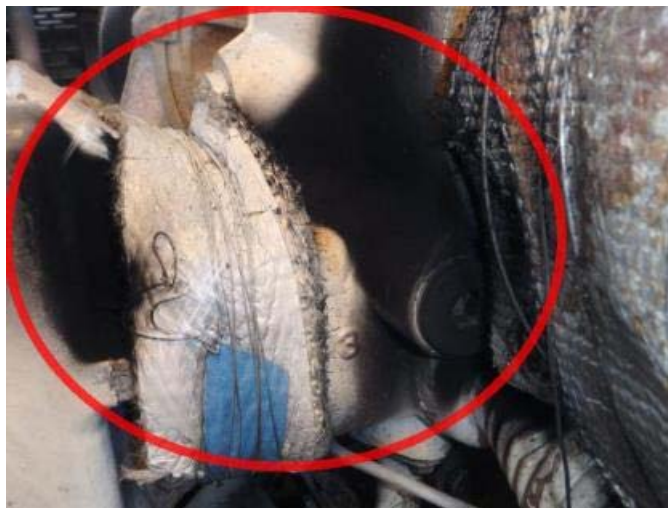
7.32 Exhaust manifold:

Appears to be cracked. Exhaust leak evident. Repair as needed.

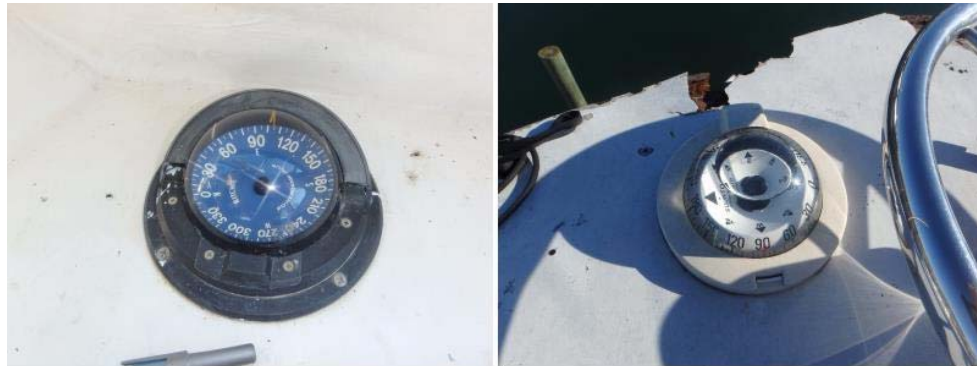
8.2 Compass(es):

Ritchie. Powerdamp. and with a 4" card. Lighted and shaded. Located on the helm dash. The compass appears functional. **There is a Suunto compass on the tower with a large air bubble. Repair or replace.**
