REPORT OF THE MARINE SURVEY

As requested, a Pre-purchase Survey was conducted of

"Lay Lo Life"

1999 Edgewater 247 CC

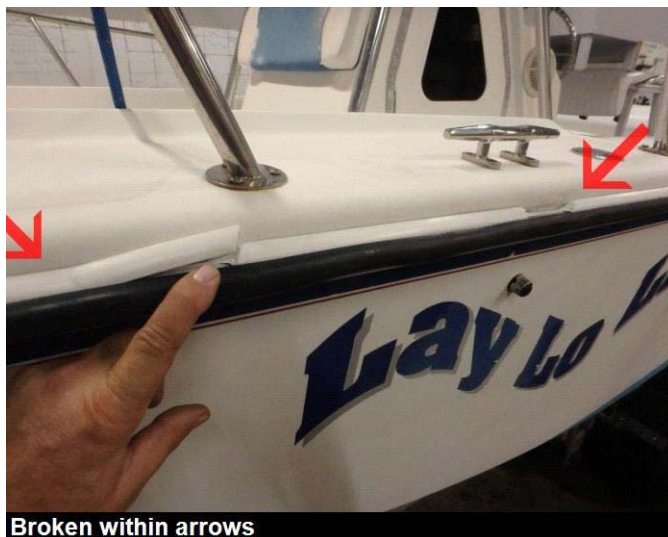
2.7 Rub rail:

White PVC rubrail with black PVC rubstrake insert. **The rubrail needs repair as follows: portside amidships. RECOMMEND repair rubrail as directed to prevent damage or injury.**

Broken within arrows

1. RECOMMEND repair rubrail portside as directed to prevent damage or injury.

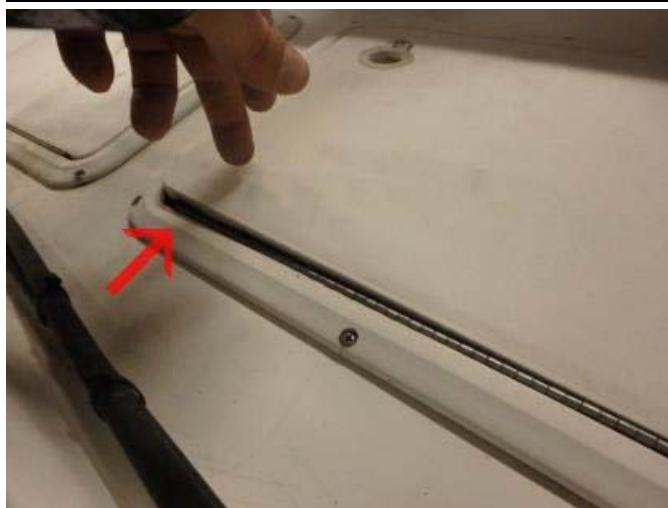
2.8 Transom:

A Euro style integral swim platform with cutout outboard(s) mount and scuppered splashwell, then a false transom. **Noted that one of the hatches in the outboard well has a bent hinge that will not allow the hatch to properly seal when closed. Repair or replace hinge.**

2. Noted that one of the hatches in the outboard well has a bent hinge that will not allow the hatch to properly seal when closed. Repair or replace hinge.

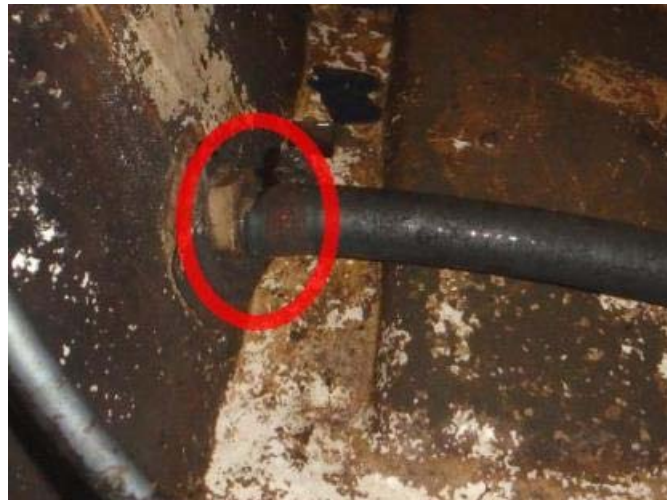
2.27 AFT BILGE :

Plastic inlet and outlet for passive baitwell circulation. No valves installed and made of plastic. Hoses are only single clamped. Recommend these below waterline fittings be replaced with bronze thru-hulls, fitted with valves, or removed and plugged. Failure would sink the boat.

4. Recommend these below waterline fittings be replaced with bronze thru-hulls, fitted with valves, or removed and plugged. Failure would sink the boat.

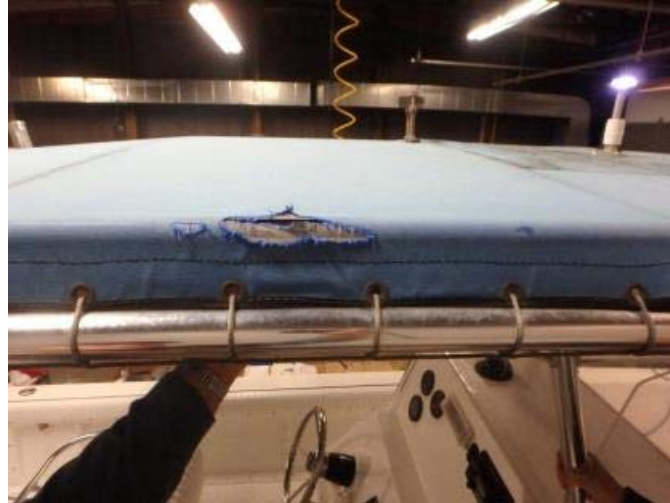
3.4 Miscellaneous

Canvas covers or convertible enclosures or tops include: **A canvas trampoline on the T-top. Two worn through spots on the stbd side should be repaired.** Top is aged.

6. A canvas trampoline on the T-top. Two worn through spots on the stbd side should be repaired.

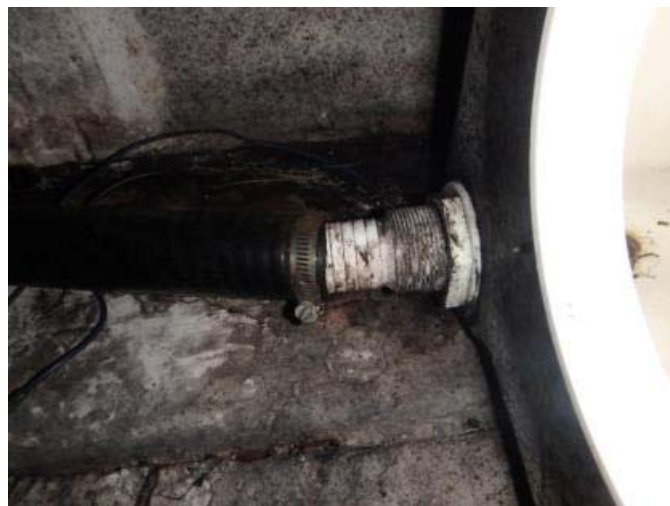
3.13 Scuppers /drains:

Scupper drains in aft cockpit sole are clear and drains overboard at the waterline. **Hoses attached to drains are not on far enough and only single clamped. Attach properly.**

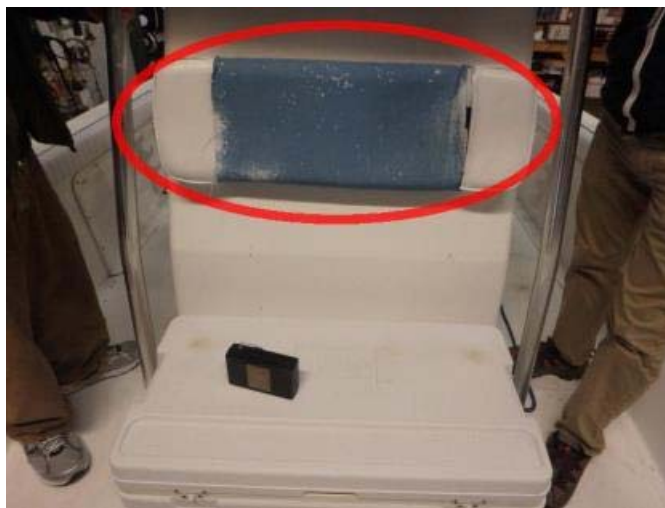
Seat forward the center console- backrest in poor condition. No cushion for the forward cooler. Vinyl stand/sit padded bolster seat at helm and side companion seat. Vinyl in excellent condition. Drop down transom seat.

9. Seat forward the center console- backrest in poor condition.

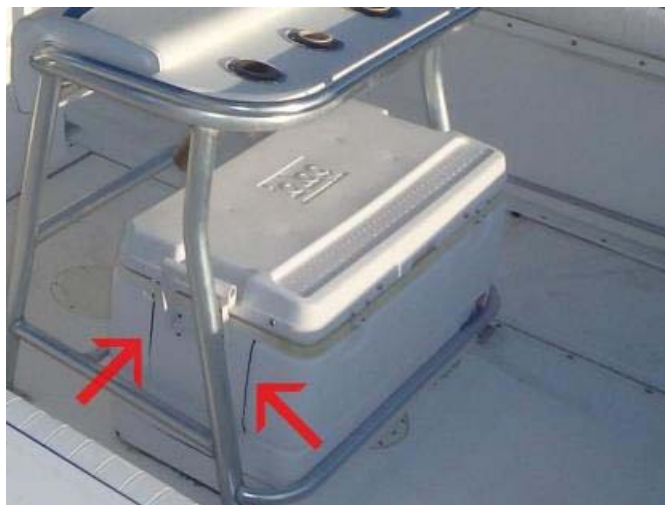
4.4 Ice locker:

2 large Igloo coolers.
Handles broken on both.
Aft cooler body is cracked.

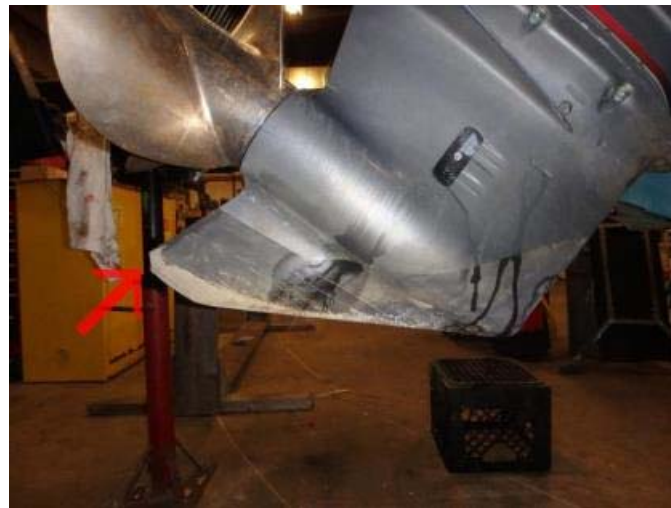
6.17 Damage sighted:

Skeg has minimal paint scuffing from contact with bottom sand. Tip is broken off.

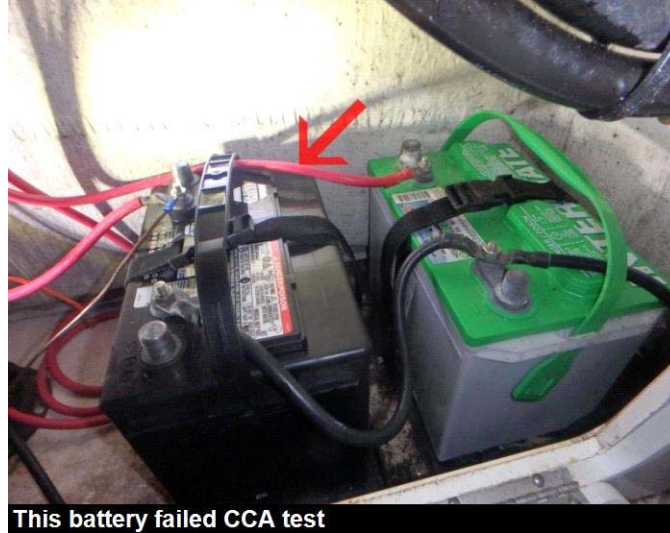
8.1 House Batteries:

There is one NAPA 12 volt, wet cell lead acid, and Group 24 size. **It failed the Cold Crank Amperage test. Replace battery.**

13. It failed the Cold Crank Amperage test. Replace battery.

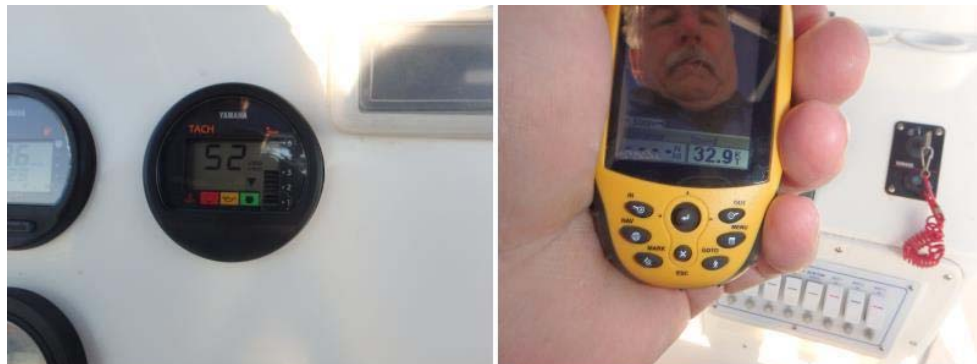
11.12 Max throttle:

Manufacturer's recommended max RPM is 4500-5500- Engine reached 5200 RPM at full throttle.
