## **REPORT OF THE MARINE SURVEY**

As requested, a Pre-purchase Survey was conducted of

**2012 Scout 225 XSF**

**Peter J. Spang, SAMS® AMS®**

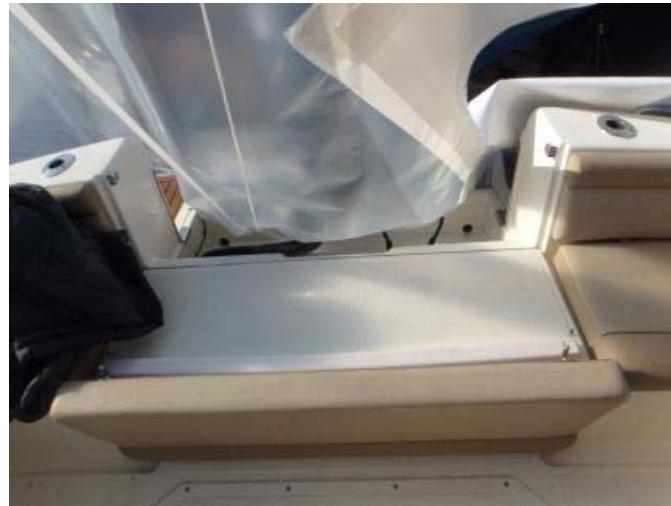
### 2.8 Transom:

A Euro style integral swim platform with cutout outboard(s) mount and scuppered splashwell, then a false transom with a gated walkthrough-(back of transom seat folds down).

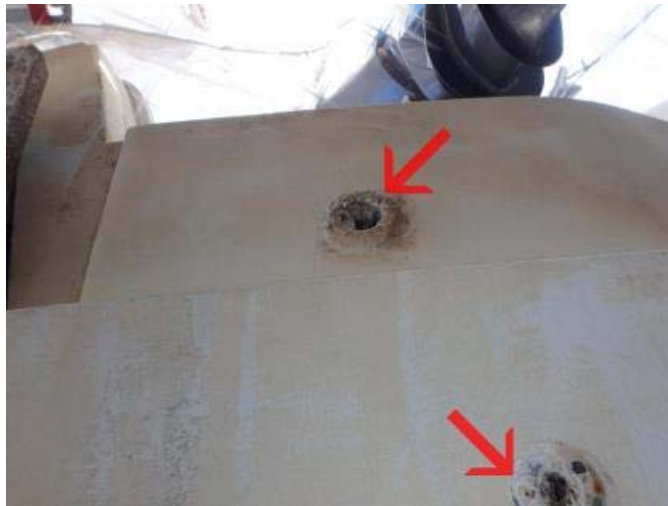
**2.17 Thru Hulls**

**Thru-hulls are somewhat choked with anti-fouling paint and marine growth, specifically; raw water intakes.**

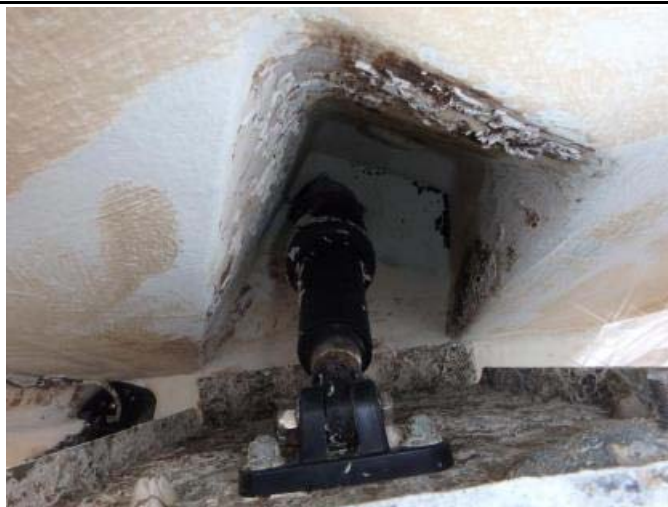
**2.21 Trim tabs:**

Lenco single ram SS. System powers up & appears functional. Digital control pad at the helm with working indicators.

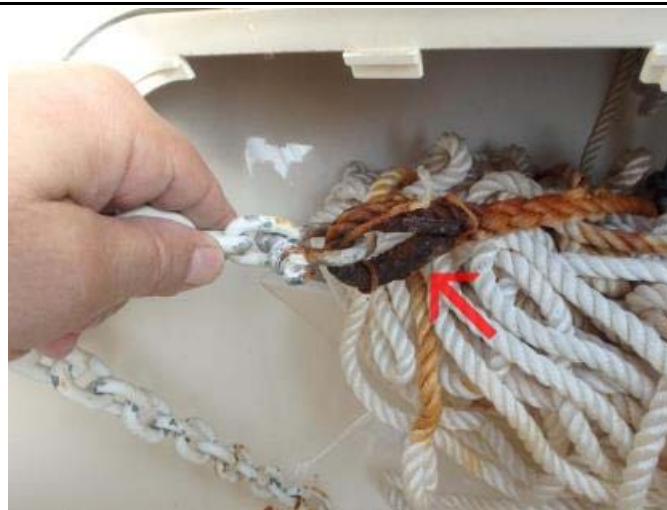
#### 3.1 Ground tackle

Ground tackle includes; A chain leader to 3 strand nylon line, (unknown length) with spliced eyes and galvanized thimbles. Shackles and swivels appear serviceable. Shackle pins are not safety wired. *Recommend SS wire or tie wraps through the shackle pins to prevent loss of rode and/or anchor.* Anchor(s) include: One and Danforth or danforth

style. *There is no secondary or backup anchor and rode as recommended in the ways of a prudent mariner.* The bitter end of the anchor rode is properly secured to vessel. System is installed and maintained to ABYC standards. Appears to be serviceable. **Note: Thimble is rusty and should be replaced.**

2. Note: Thimble is rusty and should be replaced.

- Recommend SS wire or tie wraps through the shackle pins to prevent loss of rode and/or anchor. There is no secondary or backup anchor and rode as recommended in the ways of a prudent mariner.

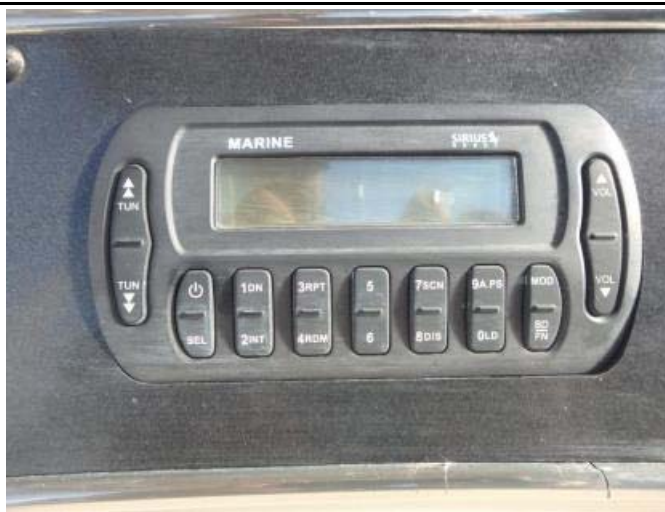
**5.1 Stereo(s):**

Located in the center console. Labeled "Marine". AM/FM/Satellite.

**5.2 Speaker(s):** By JBL. -- **all power up with stereo except the portside speaker next to the console.** Repair or replace as necessary.

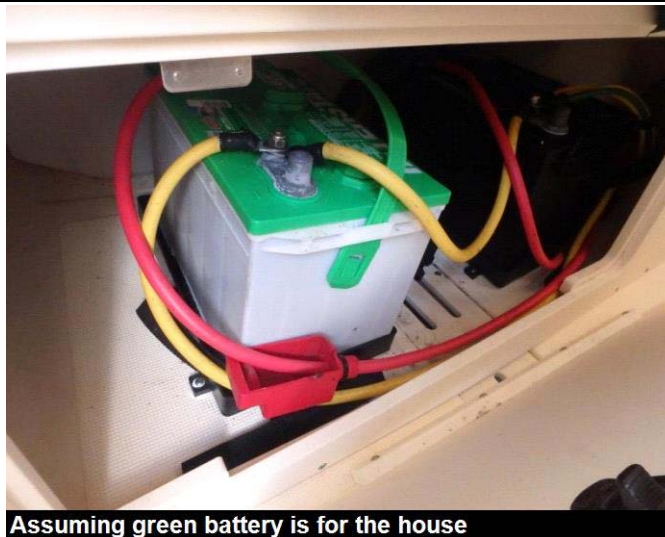
**9.1 House Batteries:**

There is one Interstate 12 volt, wet cell lead acid, deep cycle battery dedicated to engine starting function. Passed Cold Crank Amp test.

Assuming green battery is for the house

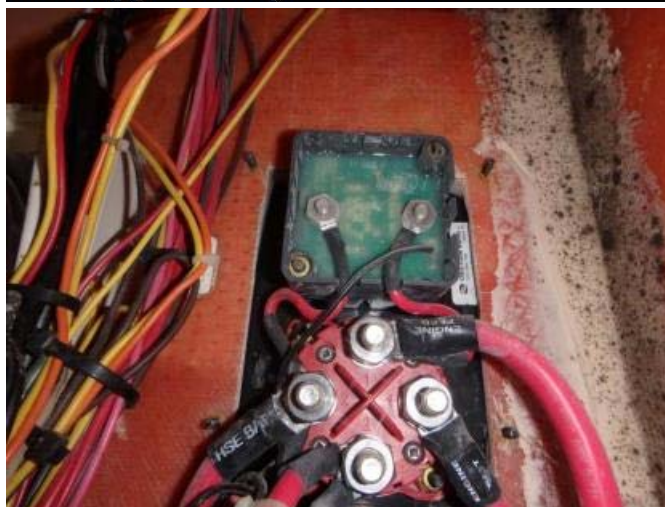
**9.2 Starting batteries:**

There is: one, 12 volt, wet cell lead acid battery. Note: As located, both batteries are virtually inaccessible without removing them. Located in a locker forward the toilet and deep in the bilge. Both batteries were tested at the rear of the battery switch and identified per markings on the switch. **Cranking battery failed the CCA test and should be**

**replaced.**

5. Cranking battery failed the CCA test and should be replaced.

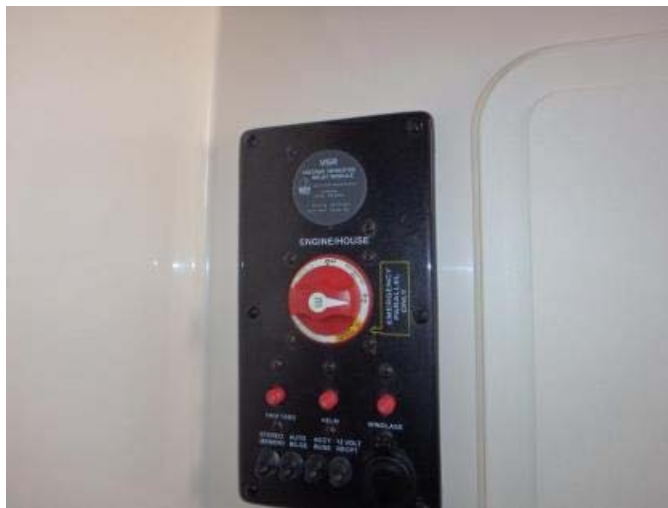
### 9.11 Battery switch:

Yes at DC Power panel and is functional.

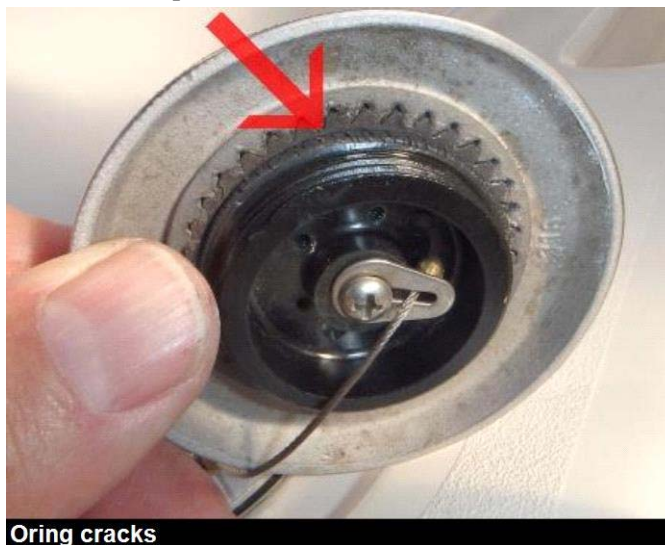
On the side deck, portside. The deck plate is clearly labeled, appears weather- tight and serviceable. Cap tether in place. **O-ring on the fuel fill cap(s) is/are in poor condition or missing. Replace O-ring to prevent water in fuel tank(s).**

**Oring cracks**

- O-ring on the fuel fill cap (and water fill cap) are in poor condition. Replace O-ring to prevent water in fuel tank (and contamination of onboard H<sub>2</sub>O).
