REPORT OF THE MARINE SURVEY

Survey completed: February 28, 2017

As requested, a Pre-purchase Survey was conducted of

2001 Boston Whaler Sport 13

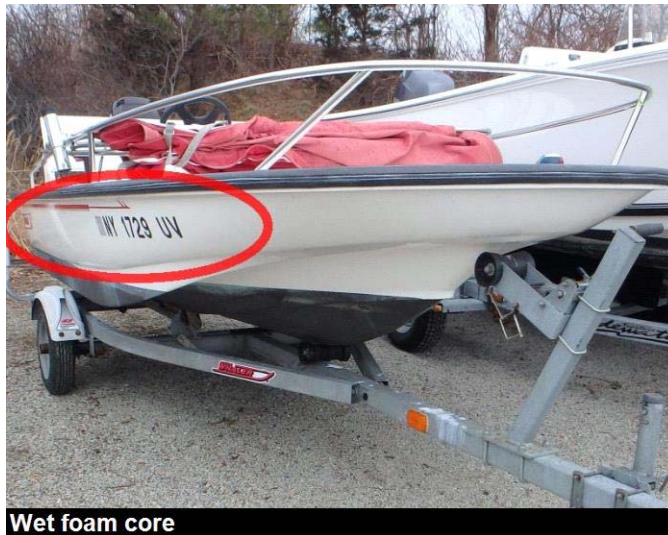
2.8 Moist./Delam.:

Moisture meter readings on topsides near the water line and surrounding thru hull fittings show wet laminate in the following areas: Both side hulls from waterline to rubrail 3/4 the way forward from the transom. See photo.

Wet foam core

The wet foam core of the topsides is not uncommon for Boston Whaler. A manufacturing issue that Whaler has struggled with for years. Generally caused by not properly sealing deck hardware fastener penetrations. Prohibitively expensive to repair, it is generally ignored unless it's extra weight raises the waterline, but considered a devaluation in the boat's market value.

2. Moisture meter readings on topsides near the water line and surrounding thru hull fittings show wet laminate in the following areas: Both side hulls from waterline to rubrail 3/4 the way forward from the transom. See photo.

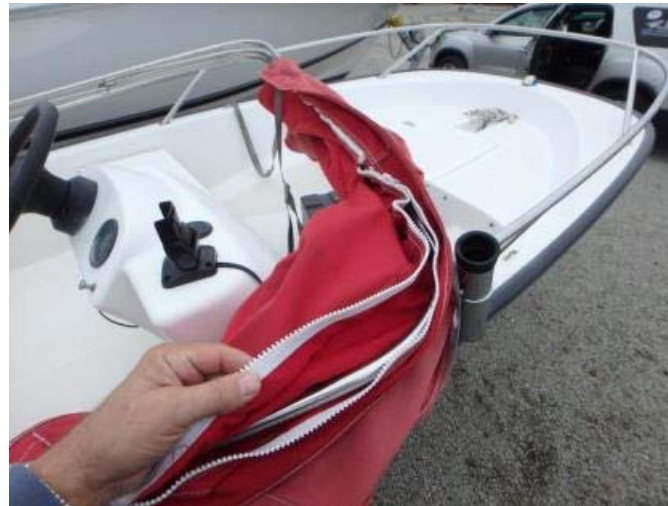
3.8 Fabric structure:

Framed Bimini top over helm. Support frame is stainless steel. Fabric is in fair condition but zippers need replacement.

2. Framed Bimini top over helm. Support frame is stainless steel. Fabric is in fair condition but zippers need replacement.

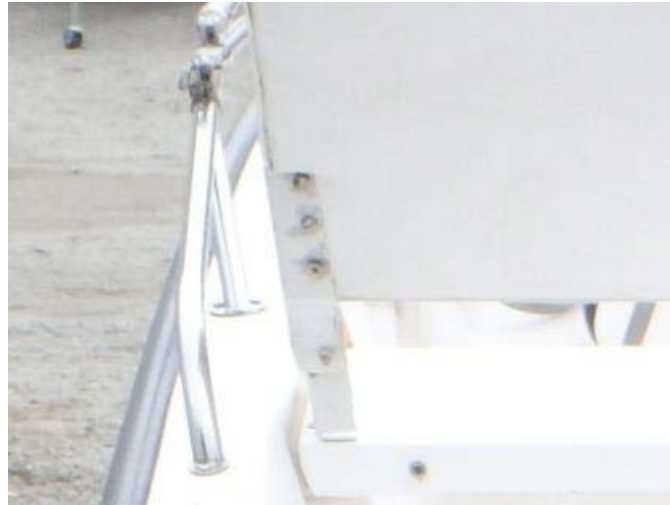
3.15 Seating:

Vinyl cockpit cushions are missing or unavailable. Bench seat-back has been crudely refastened.

4. Vinyl cockpit cushions are missing or unavailable.

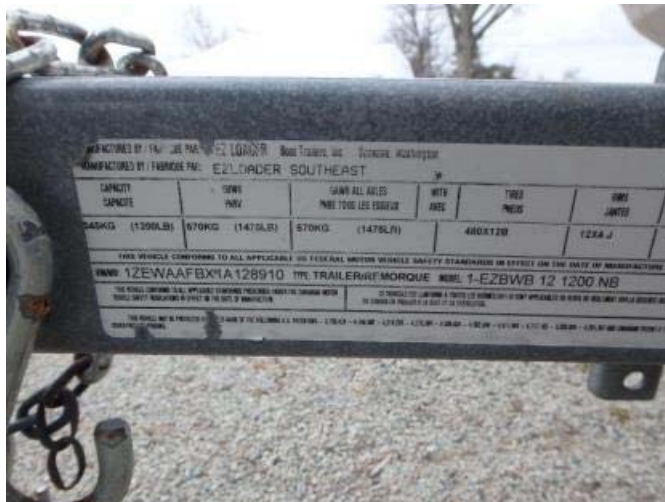
9.3 Trailer serial #:

VIN #1ZEWAAFBX1A128910.
