REPORT OF THE MARINE SURVEY

"Carol Cee 3"

2004 Grady White Marlin 30

Peter J. Spang, SAMS® AMS®

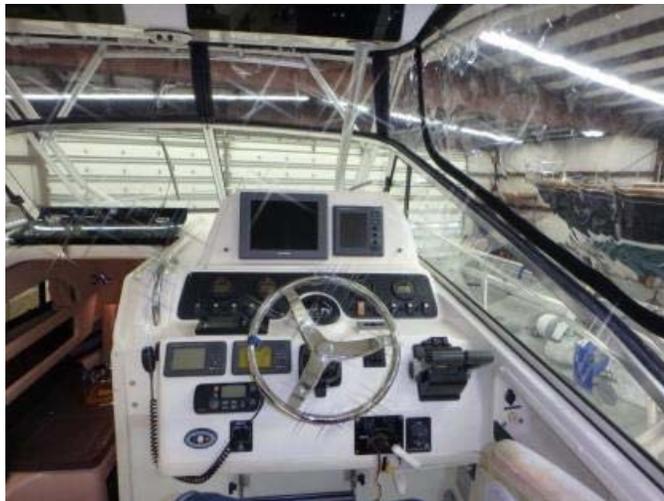
3.23 Cockpit /Helm:

Helm is in the bridge. Adjustable pedestal seats for pilot and passenger.

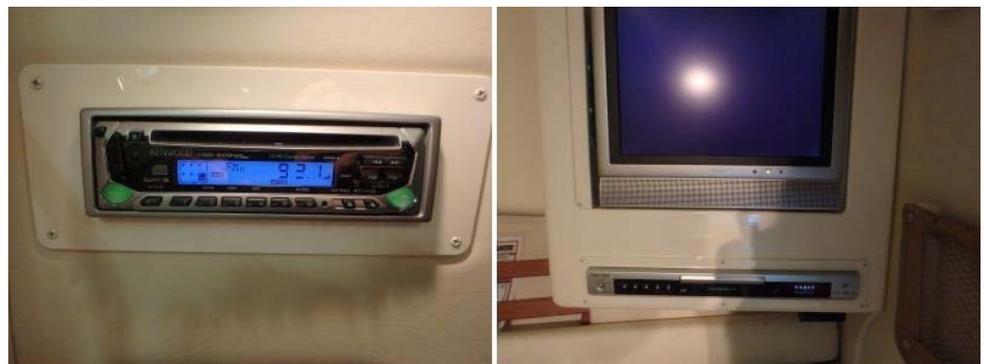
5.4 Entertainment

Entertainment includes: An AM/FM/CD stereo by Kenwood, Model KDC-202MR. Appears serviceable- CD player not tested. Serviceable remote pad at the helm. A flatscreen TV by Sharp, and DVD player also by Sharp. Both power up but not tested. Vessel is wired for dockside cable and has an A/B switch ready for an antenna installation.

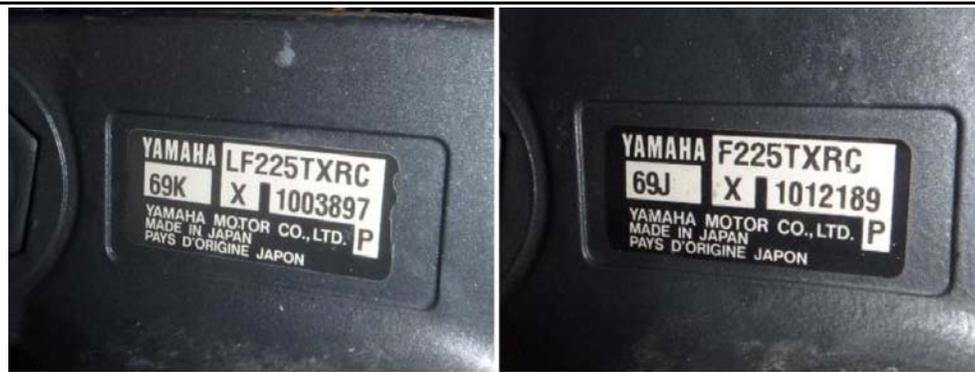
7.1 Propulsion:

The vessel is propelled by dual engines, gasoline fueled, 4 stroke, V6 cylinders

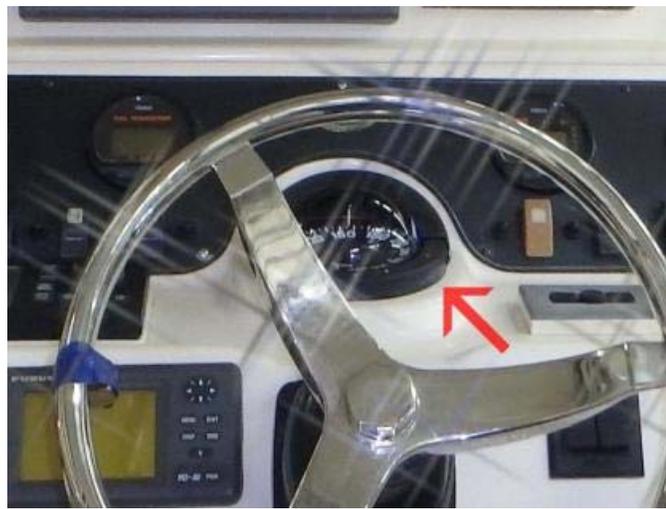
8.2 Compass(es):

Ritchie. Powerdamp. and with a 5" card. Lighted and shaded. Located on the helm dash. The compass appears functional.

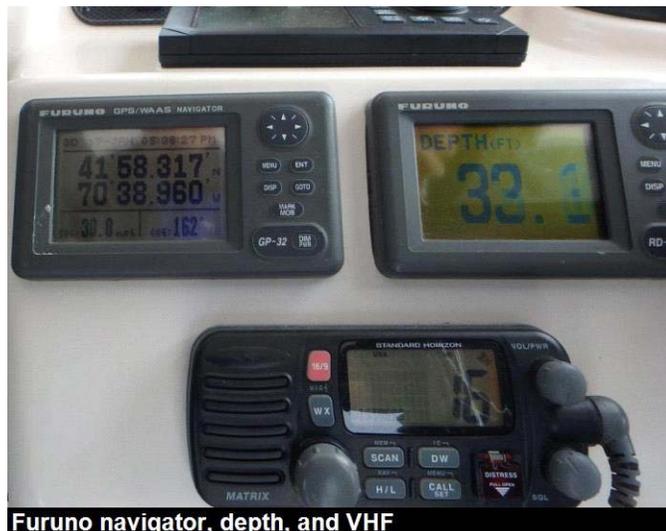
8.3 VHF radio(s):

Furuno navigator, depth, and VHF

Standard Horizon, Matrix GX3000S, *This VHF radio has a NMMEA interface and is DSC capable- register the vessel and owner with the USCG. Go to <http://www.boatus.com/MSI/> to obtain a MMSI number- it's free.* At sea trial radio powers up and transmits/receives- appears serviceable.

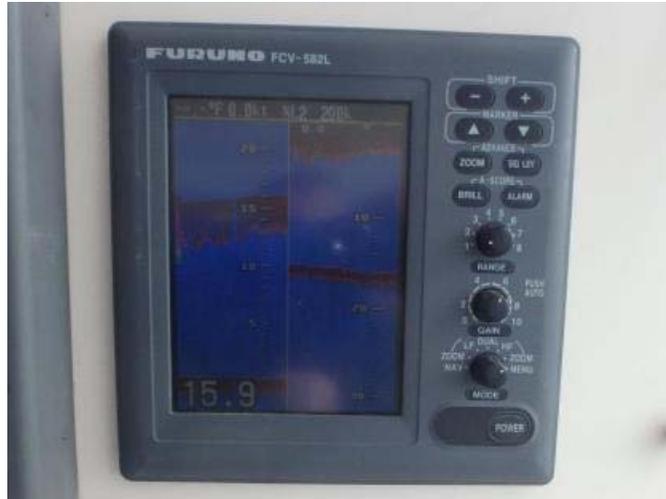
8.5 Fish finder(s):

Furuno- FCV 582L color display. The Fish Finder powers up.

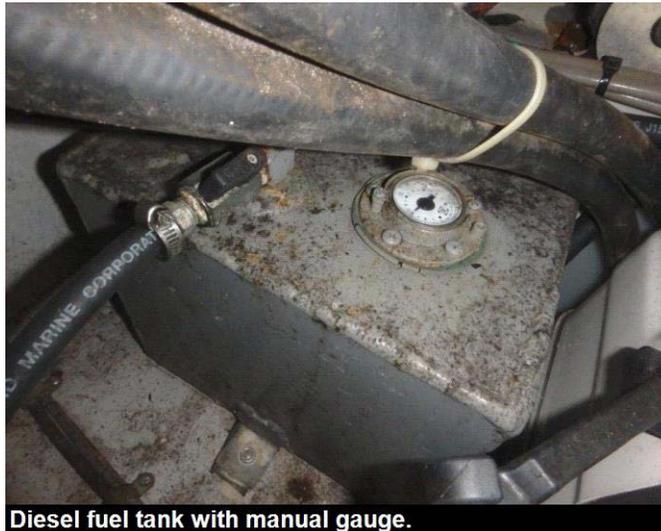
10.3 Fuel Tanks

Diesel fuel tank with manual gauge.

There are 2 fuel tank(s) made from, 5052 aluminum with a combined capacity of 306 gallons. Tank meets accessibility requirements. Deck fill plate, hoses, vent, supply and return lines and fittings inspected and tank has: A fuel gauge sending unit. Fuel piping is: USCG Type A-2 fuel hose for fill hose and vent applications. Metallic fuel fill deck plate is

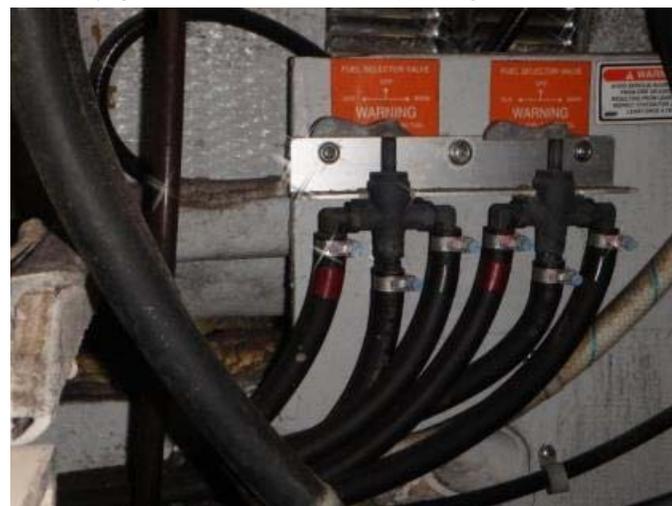
10.13 Shut off valve(s):

Fuel tank manifold and feed lines are at all points higher than the fuel tank(s) outlets and the ball valves are operational.
