REPORT OF THE MARINE SURVEY

As requested, a Pre-purchase Survey was conducted of

"Fortuna"

1986 Shannon Brenden 32

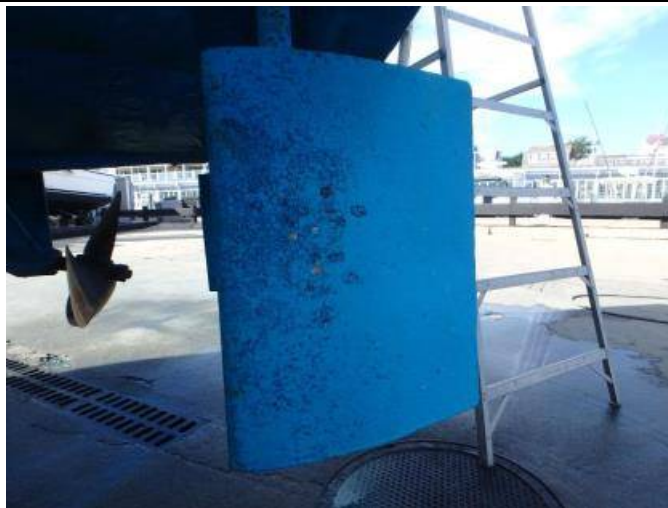
2.18 Rudder type:

Custom made hollow stainless steel with 1 1/4" SS stock. Both rudders appear well secured. No excessive vertical or fore/aft movement.

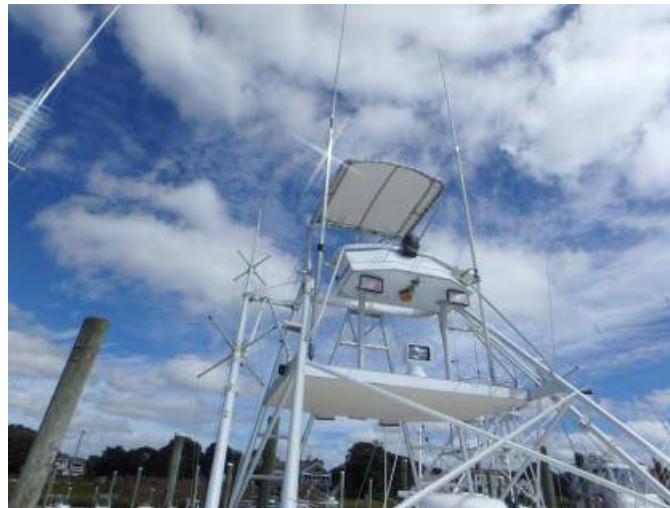
Upper helm is not functional. All gauges need to be replaced. Throttle and shift not functional. VHF radio not functional. Steering works and compass OK.

Padding good. No seat.

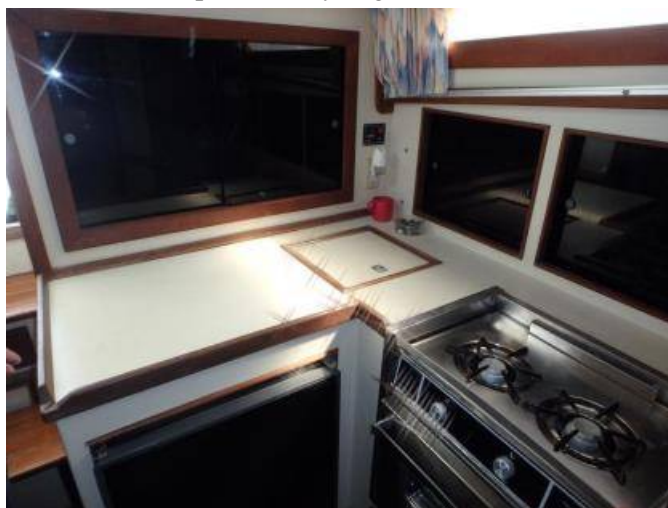
5.2 Galley

Galley is well equipped and clean. Galley appliances include: A clean Hillerange LP gas powered galley stove and pot retainers- (not tested- no gas). A microwave oven. A toaster oven. Refrigeration is a Norcold Model DE-490 AC or DC powered, undercounter, refrigeration /freezer unit with an air cooled heat exchanger. Countertop

area and storage space is adequate. Galley basin has hot and cold pressurized water. All systems powered up and appear serviceable.

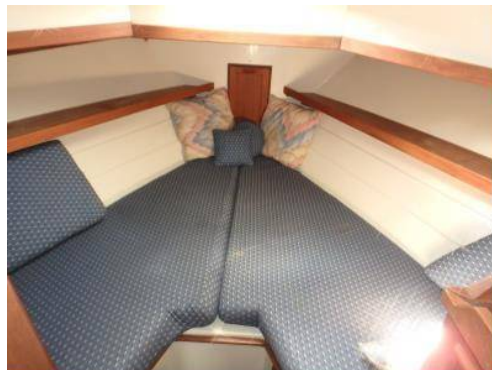
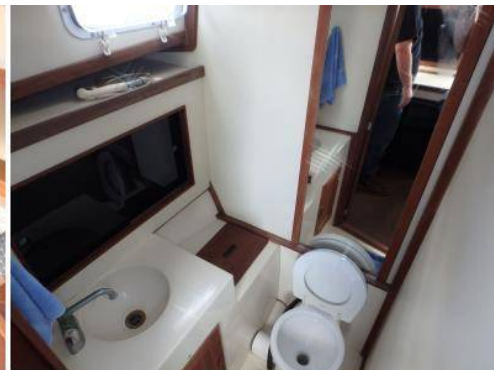
5.3 Accommodations

There are sleeping facilities for (3-4) persons located in the V-berth and the main cabin's convertible dinette with drop down table. The enclosed head has: A basin, with hot and cold pressurized fresh water. A flushing marine toilet and a convertible shower with hot and cold fresh water.

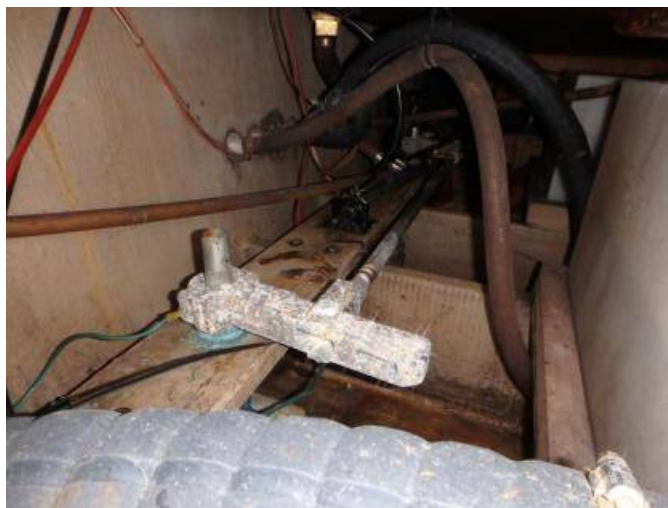
- 6.3 Lines and fittings: Flexible hydraulic lines from steering head to ram(s). No leaks sighted.
- 6.4 Reservoir tank: Lower helm steering fluid reservoir is full.
- 6.5 Mounting(s): Cylinder & ram actuator well secured-no leaks sighted.
- 6.6 Rudder stock(s): Stock(s) appear visually sound and is constructed of 1 1/4" stainless steel.
- 6.7 Rudder post: Wooden plank with bearings. Appears solid.

- 6.8 Steering tie bar: Well mounted with rudder steering arms connected by a stainless steel lateral bar.
- 6.9 Packing gland(s): *No sign of excessive leakage or water tracks sighted. Monitor rudder packing gland frequently for leaks.*
- 6.10 Condition summary: Steering system meets ABYC standards, turns smoothly and easily, appears serviceable.

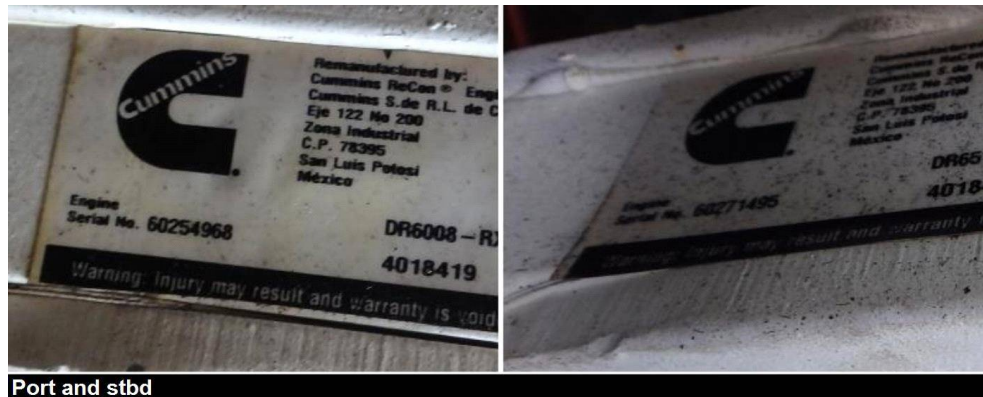
7.1 Propulsion:

Port and stbd

The vessel is propelled by dual engines, diesel fueled, 6 cylinders inline, and turbocharged with aftercooling. Inboard(s) system installation manufactured by: **Cummins- Engine year:** Factory remanufactured installed 2010 and **Model: 6BT. Producing: 220 hp @ 2600 rpm. Serial #(s)- Port engine:60254968 Starboard engine: 60271495. Hours: Port engine: 968 Starboard engine: 956.**

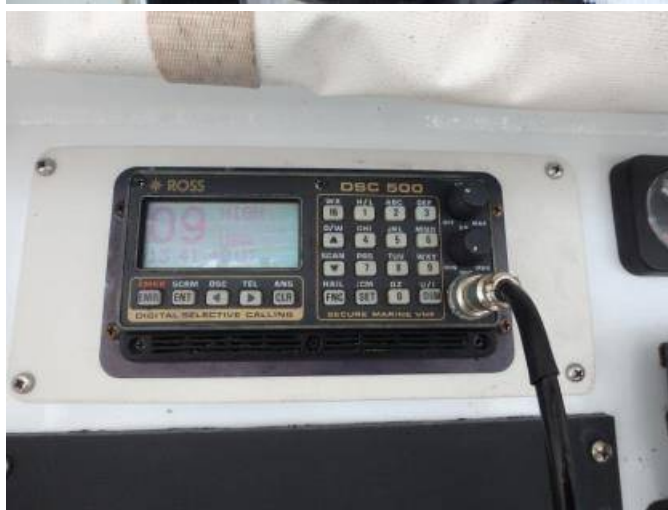
8.3 VHF radio(s):

Ross DSC 500. *This VHF radio has a NMMEA interface and is DSC capable- register the vessel and owner with the USCG. Go to <http://www.boatus.com/MMSI/> to obtain a MMSI number- it's free.* Radio powers up. At sea trial radio powers up and transmits/receives- appears serviceable.

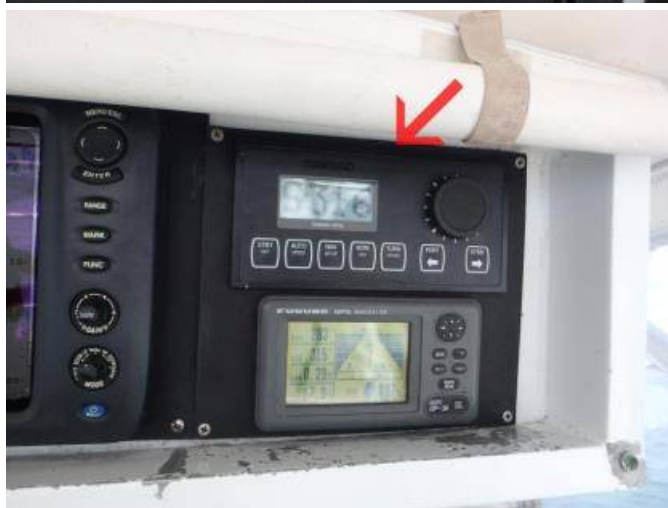
8.4 Autopilot(s):

SIMRAD AP35 model. Unit powers up.

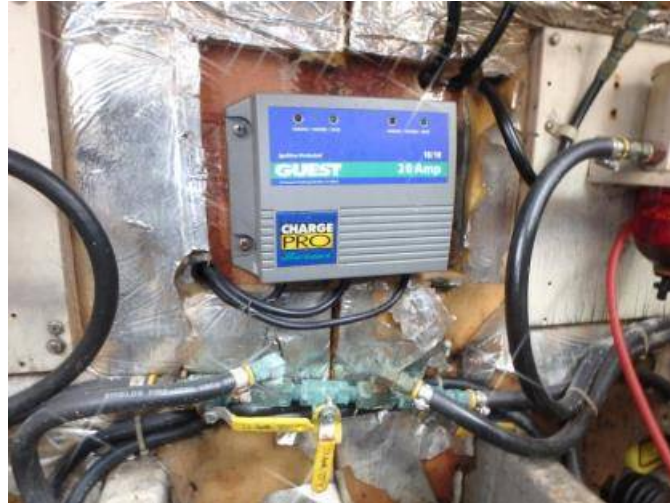
9.3 DC system:

There are two 4 position rotary switches. They are appropriate, accessible and functional. Panels and meters are marine appropriate and appear functional. Overcurrent protection is installed on each branch of the DC system. The DC electrical system utilizes appropriate marine grade UL approved wire, properly bundled and supported wherever

sighted. Battery charging via engine alternator, and a shore power converter by Guest Charge Pro (2 bank/20 amp)- appears recent.

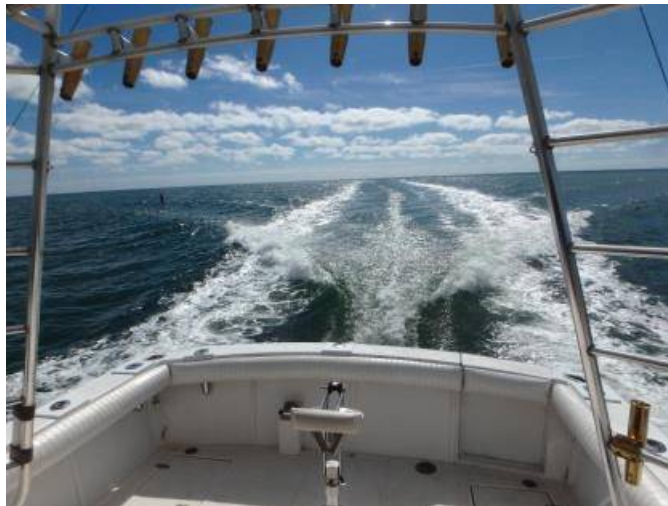
12.12 Max throttle:

Manufacturer's recommended max RPM is 2600- Engines reached 2600 RPM at full throttle.
