## **REPORT OF THE MARINE SURVEY**

**As requested, a Pre-purchase Survey was conducted of:**

**2012 Cruisers 310 Express**

**Peter J. Spang, SAMS® AMS®**

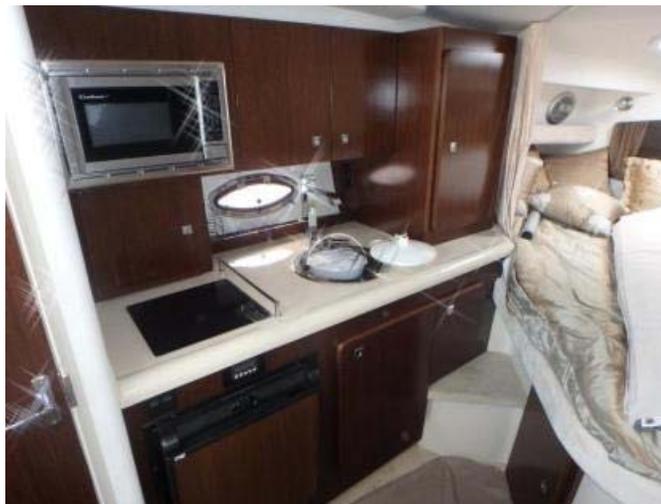
#### 4.2 Galley

Galley is well equipped and clean. Galley appliances include: A single burner Euro Kera Gourmet all electric powered galley stove with a ceramic cooking surface and with power on indicator lights. A SS Contoure microwave oven with carousel. Refrigeration is a Norcold model DE0751BB, AC or DC powered, undercounter

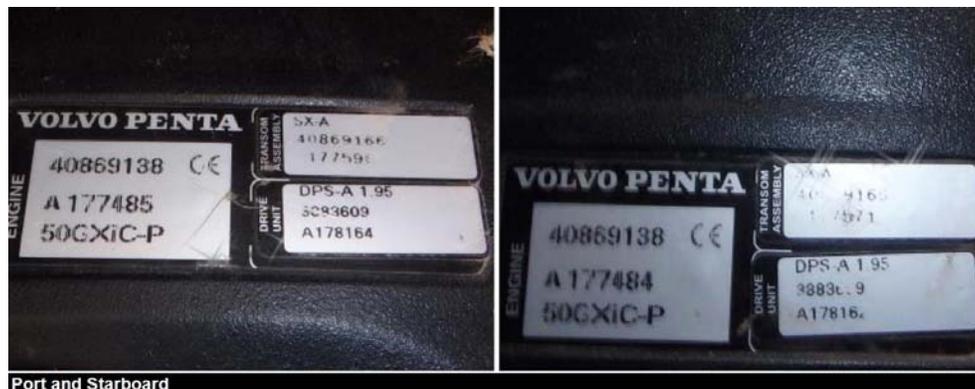
### 6.1 Propulsion:

The vessel is propelled by a twin engine, gasoline fueled, 4 stroke, V8 cylinders configuration, and naturally aspirated. Inboard/outdrive(s) system installation manufactured by: **Volvo Penta. Engine year: 2012 and Model: 5.0 GXi. Producing: 270 HP rated @4800 to 5200 RPM. Serial #(s)- Port engine: A177485 Outdrive: A178164. Starboard engine: A177484 Outdrive: A178162. Hours: 325 both.** (Hours read from onboard instruments).

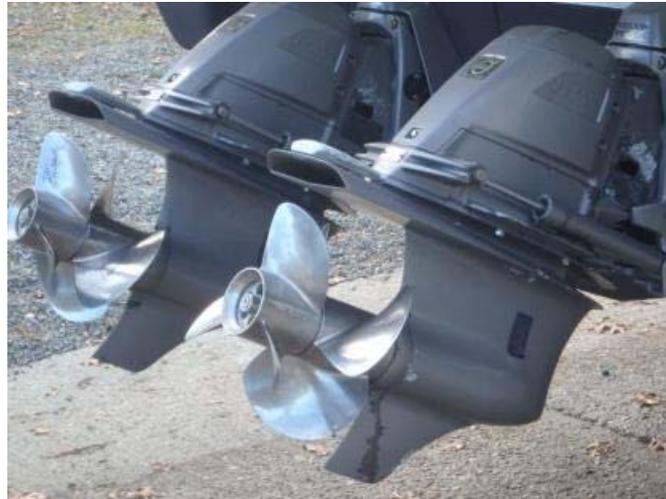
6.27 No /Make /Model:

Two Volvo Penta model DPS-A Duoprop.

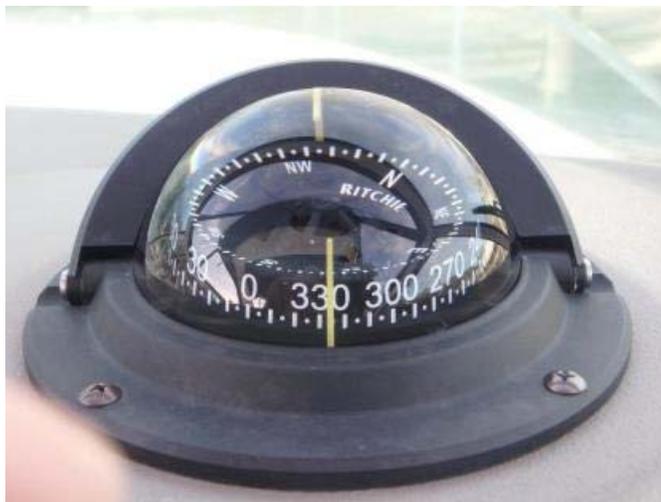
Ritchie. With a 4" card. Lighted and shaded. Located on the helm dash. The compass appears functional.

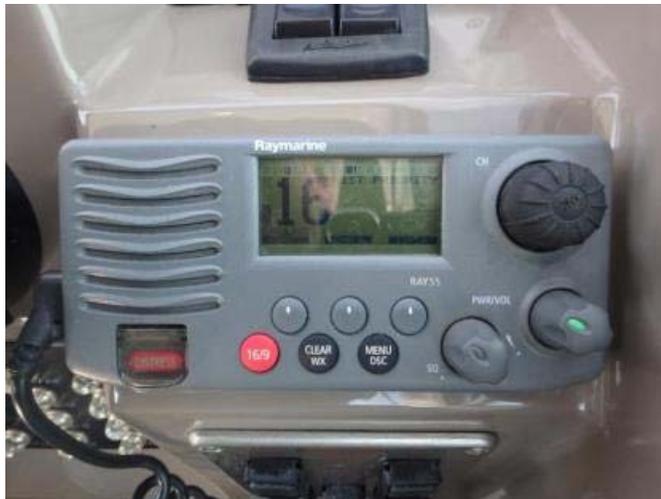
**7.3 VHF radio(s):**

Raymarine. *This VHF radio has a NMMEA interface and is DSC capable- register the vessel and owner with the USCG. Go to <http://www.boatus.com/MSI/> to obtain a MMSI number- it's free. Radio powers up. (no answer from radio check- tested from my walkie talkie only).*

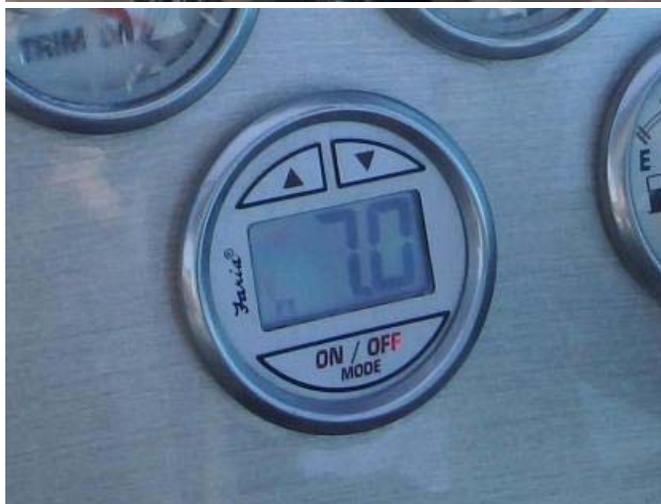
**7.4 Depth sounder(s):**

Faria digital readout with shallow alarm. Instrument powers up.

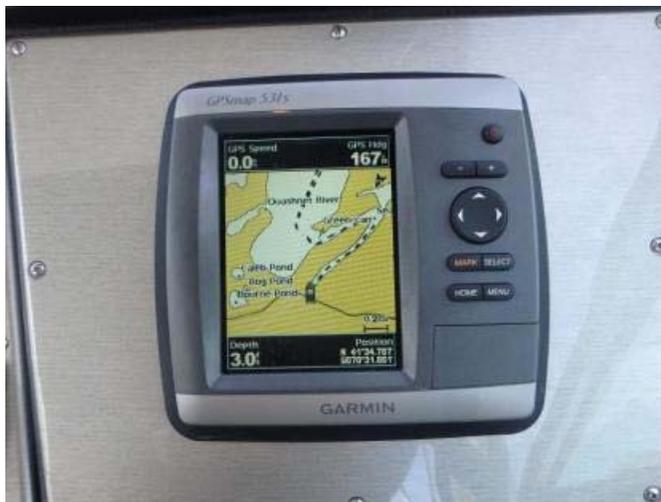
**7.6 Chart plotter(s):**

Garmin GPSmap 531s. The GPS map instrument powers up.

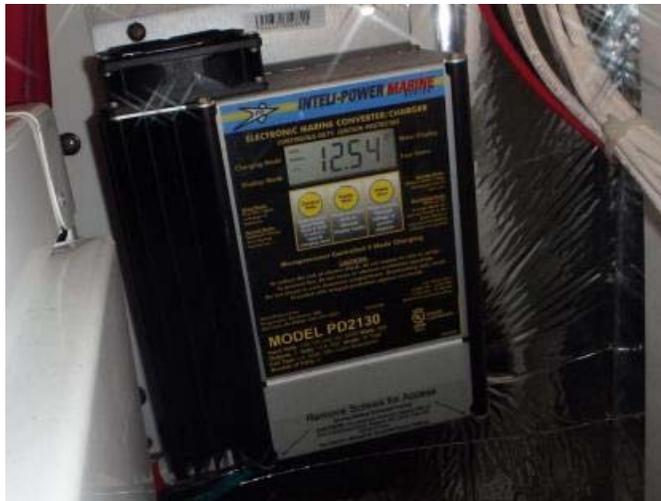
**8.12 Charging system:**

AC to DC battery converter/charger: Intel-power Marine. 30 amp total for 3 banks. Ammeter and indicator light. Charger is ignition protected. All power up and appear serviceable. Installed to ABYC standards.

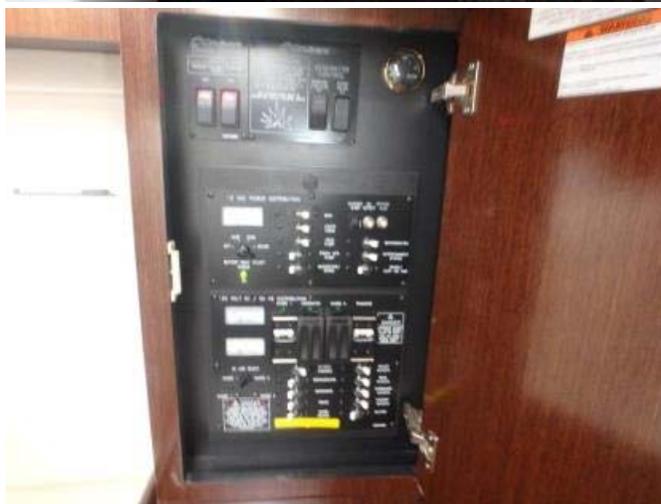
**8.13 DC panel:**

Yes, located in the main saloon and the helm. Each branch switch is clearly labeled as to purpose. Backside of panel is appropriately protected. Combined AC/DC/ and genset controls.
