## **REPORT OF THE MARINE SURVEY**

As requested, a Pre-purchase Survey was conducted of

**2012 Scout 225 XSF**

**Peter J. Spang, SAMS® AMS®**

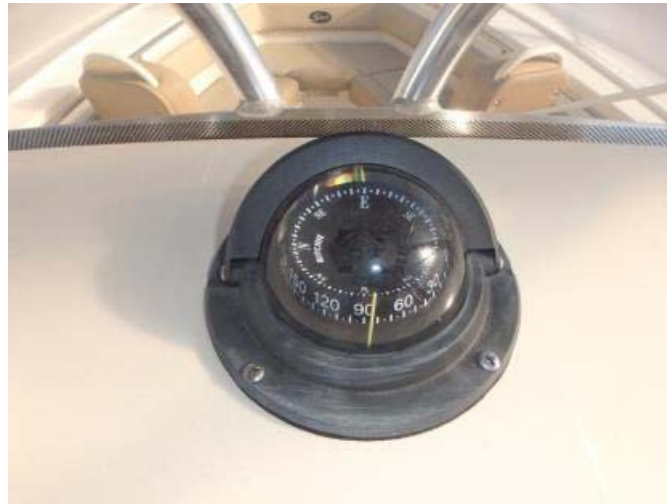
**8.2 Compass(es):**

Ritchie. With a 4" card.  
Lighted and shaded.  
Located on the helm dash.  
The compass appears functional. No statement as to its accuracy can be made.

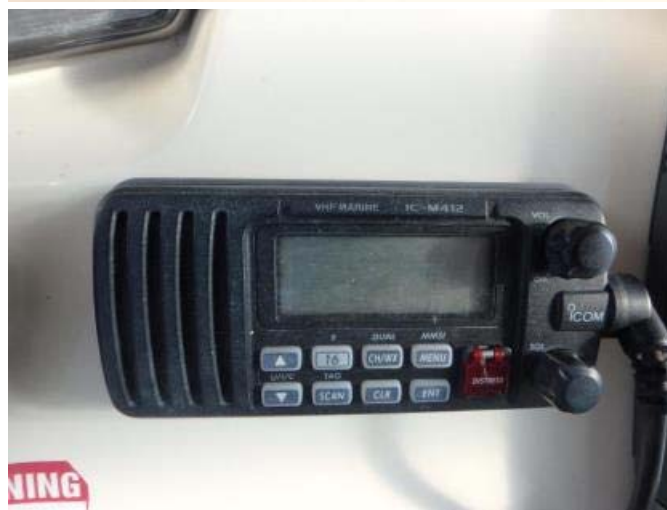
**8.3 VHF radio(s):**

ICOM, ICM-41 2 model.  
*This VHF radio has a NMMEA interface and is DSC capable- register the vessel and owner with the USCG. Go to <http://www.boatus.com/MMSI/> to obtain a MMSI number- it's free. A wired RAM is at the helm. Radio powers up. Not tested.*

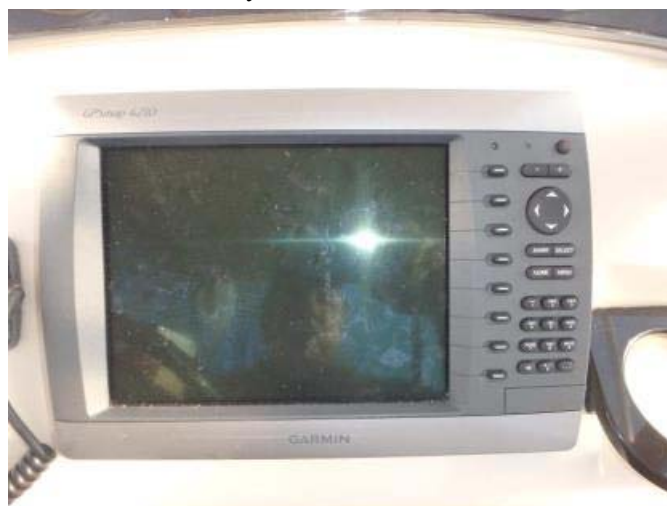
**8.7 Multi-function:**

Garmin multi functional-  
multi functional-  
GPSmap 4210.  
Instrument powers up.

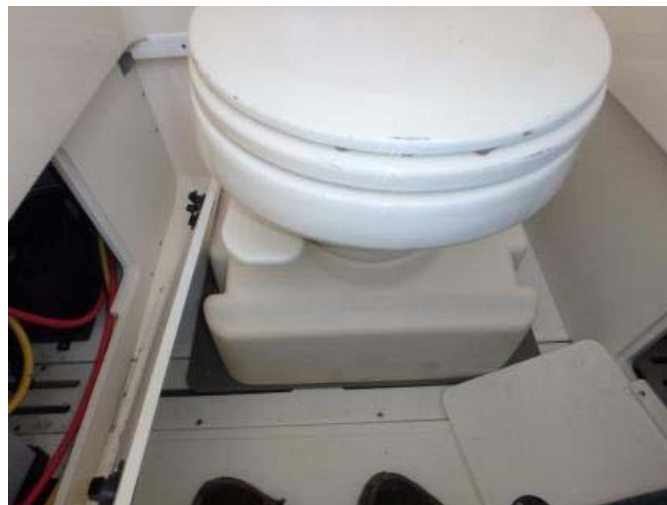
**10.18 Sanitation Device:**

Type III-A system self contained. Holding tank integral with toilet must be pumped out to be emptied.

- 10.19 Tank(s) Material:** Manufactured of molded polyethylene.
- 10.20 Capacity:** 10 gallons per broker's listing.
- 10.21 Monitor system:** Tank is translucent and level can be seen through tank sides.
- 10.22 Tank(s) secured:** Tank is well secured.
- 10.23 Access:** Available.
